STAFF REPORT

File Number	PL 14-034	Contact	Jenn Reed Moses, jmoses@duluthmn.gov	
Application Type	Shoreland Variance	Planning Commission Date	May 13, 2014	
Deadline for Action	Application Date	April 8, 2014	60 Days	June 7, 2014
	Date Extension Letter Mailed	April 22, 2014	120 Days	August 6, 2014
Location of Subject	1726 Piedmont Ave			
Applicant	Dennis Michaud	Contact	boman12120@yahoo.com	
Agent	Kate Kubiak, South St. Louis SWCD	Contact	218-723-4946; kate.kubiak@southstlouisswcd.org	
Legal Description	010-2880-00270			
Site Visit Date	N/A	Sign Notice Date	April 22, 2014	
Neighbor Letter Date	April 24, 2014	Number of Letters Sent	32

PL 14-034
1726 Piedmont Avenue

**Re: Slope Stability Evaluation
1726 Piedmont Avenue
Duluth, MN 55811**

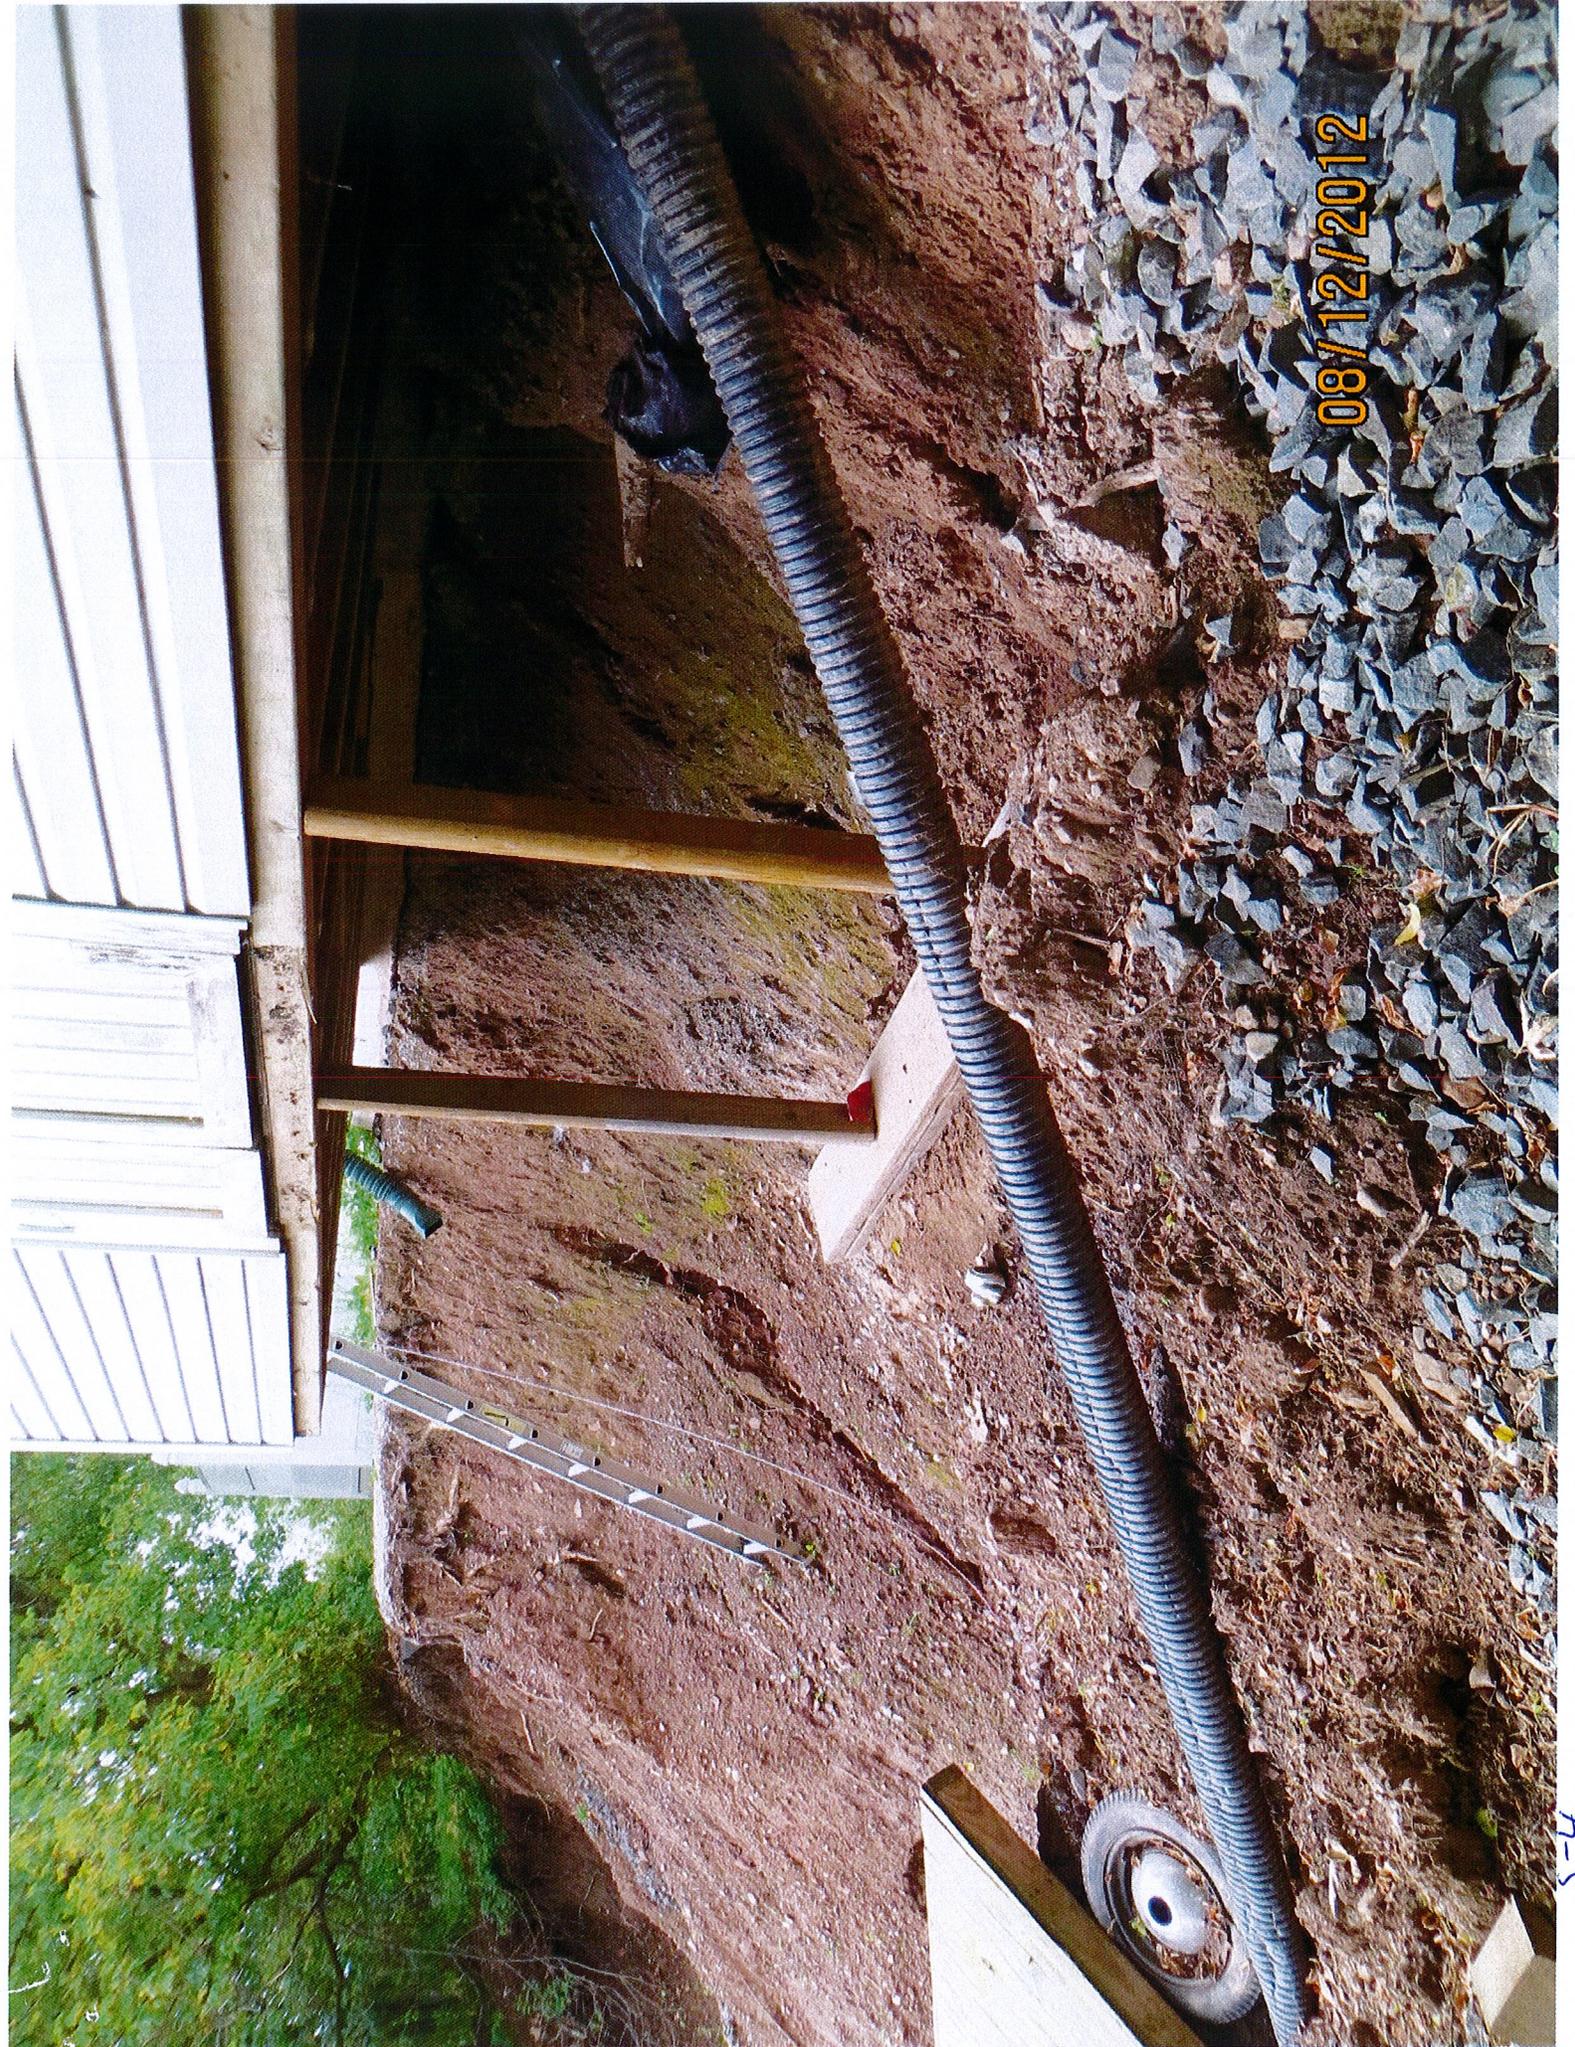
S-4

- 1.) This property was severely damaged during the June 2012 flood, with approximately 30 feet of the rear of the property sloughing into the ravine below. As a result, the garage is currently suspended over the collapsed bank.

The Dennis Michaud property at 1726 Piedmont Avenue was severely damaged during the June 21st, 2012 flood. A large portion of the slope immediately behind the garage sloughed into the ravine (Miller Creek tributary) about 150 feet below. The neighboring property to the SE at 1720 Piedmont (Jim Winklesky) is also slightly affected. Mr. Michaud lost approximately 30 feet of his property off of the back (northeast) part of his lot, including the back of his garage, which is currently suspended over the collapsed bank (see attached photos). The City instructed Mr. Michaud to vacate the compromised garage due to the damages in June of 2013.

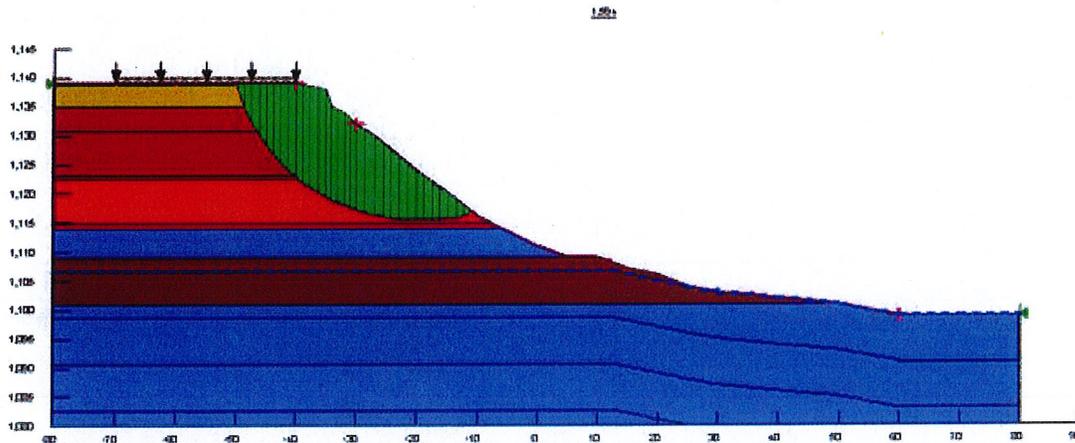
Output from GeoStudio 2007 SLOPE/W

Slope stability analyses were performed to evaluate the stability of the existing slope. A representative cross-section, taken from the results of the laser survey collected by Barr on June 24, 2013, was used to represent the overall slope condition and geometry. The cross-section used in the analysis is illustrated on Figure 3.

A factor of safety (FOS) equal to or greater than 1.5 against global slope failure under normal loads is considered adequate for long-term stability. Based on the method used for this analysis, the current slope has a FOS of just over 1.5 for global (large-scale) stability, but just over 1.0 for shallow sloughing failures

of near surface soils. However, the analysis is a “snapshot” in time and represents the geometry and soil conditions at the time of the subsurface investigation and survey. External forces are the greatest risk to long-term stability for this slope. Forces such as wind, rain, snow, drainage, and freezing temperatures are not easily modeled with available slope stability computer programs because the frequency and intensity can change dramatically over time. Additionally, the lack of surface vegetation, which tends to “knit” the soils together, will negatively impact the stability over the long-term. Near surface surficial sloughing will continue indefinitely because of the exposed nature of the slope. These surface sloughing failures cause an immediate threat to the safety of the existing garage.

The near surface soils within the slope are in a state of failure with the current having a factor of safety just over 1.0 (incipient failure and expected). The existing garage structure (or portions of) and portions of the driveway are in imminent risk of toppling should additional slope movement occur. The relatively dense glacial till overburden soils provide moderate protection against a deep-seated global stability failure. Vegetation, specifically large diameter trees and their roots that extend into the overburden soils were toppled during the flood or as a result of the recent slope failures. This lack of substantial vegetation further de-stabilized the slope. Continued erosion associated with rain and surface drainage flow from the driveway and roof downspouts will continue to erode the slope indefinitely until a stable slope angle is achieved. We have provided the following alternatives with varying costs and benefits to address the current slope stability issue. The intent of these recommendations is to address long-term stability of the slope.

The slope could be left in its current state, recognizing that additional sloughing and erosion will occur. This erosion and sloughing will continue until the slope flattens to the soils angle of repose (a stable incline). Because of the granular nature of the glacial till and the relative density of the in-situ soils, this will likely occur at a slope of about 1.8H:1V to 2H:1V. Based on this stable slope

Place large diameter rip-rap along the face of the slope to increase long-term stability and provide additional means of erosion protection. This approach provides weight along the face of the slope to physically restrict further movement and increase the overall factor of safety while simultaneously adding an erosion resistant material to further limit mass wasting by overland flow and erosion of the toe by moving water caused erosion. Dual geotextile separation fabrics would be placed and secured to the slope prior to the rip-rap placement to provide erosion control during construction as well as to prevent migration of fine-grained soils within the slope through the rip-rap. The slope geometry may have to be flattened or terraced in order to allow equipment access and to place the separation fabric prior to the placement of rip-rap stones. Depending on the actual size of the rip-rap stones and final geometry of the slope, grouting of the rip-rap may be required. A drainage swale would also be constructed along the crest of the slope to channel surface flows to a specific area of the slope to minimize the amount of water flowing over the face of the slope. This option would require a portion of the existing garage to be demolished in order to achieve a recommended minimum 15 foot setback from the slope crest. Existing land loss associated with the observed slope failure would not be recovered. Permits from the City of Duluth and the Minnesota Department of Natural Resources (DNR) would be required to complete this work.

A gravity retaining wall could be installed to stabilize the slope and provide long-term erosion control protection. The toe of the slope (below the wall) would be armored with rip rap or a cable-stayed concrete erosion mat to provide scour protection should a similar flood event occur during the serviceable life of the armor system. The retaining wall would be constructed with the base of the wall at approximately elevation 1,110 feet and extend to the existing driveway grade at approximately elevation 1,138 feet. A mechanically stabilized earth (MSE) wall could be constructed, which would allow for a near vertical wall face and maximum land recovery (up to about 20 feet). This type of wall requires the use of geotextile or geogrid reinforcement installed horizontally behind the wall to provide pull out and overturning resistance, which increases the amount of earthwork associated with construction. An alternative would be to construct a gabion basket wall, which is strictly a gravity type retaining wall that utilizes the weight of the stones installed within the gabion baskets to provide overturning resistance. The gabion basket wall would be constructed with an overall slope no steeper than 1H:1V, or preferably in a series of 6 to 8 foot terraces. Based on our preliminary layout, about 10 feet (horizontal) of land could likely be reclaimed using the gabion basket wall. Depending on the final layout of the retaining wall, reinforcement lengths, and required property line setbacks, the entire garage could likely be saved with the retaining wall option. However, if additional damage occurs to the garage prior to construction, demolition of portions of the garage could be inevitable. Permits from the City of Duluth and DNR would be required to complete this work.

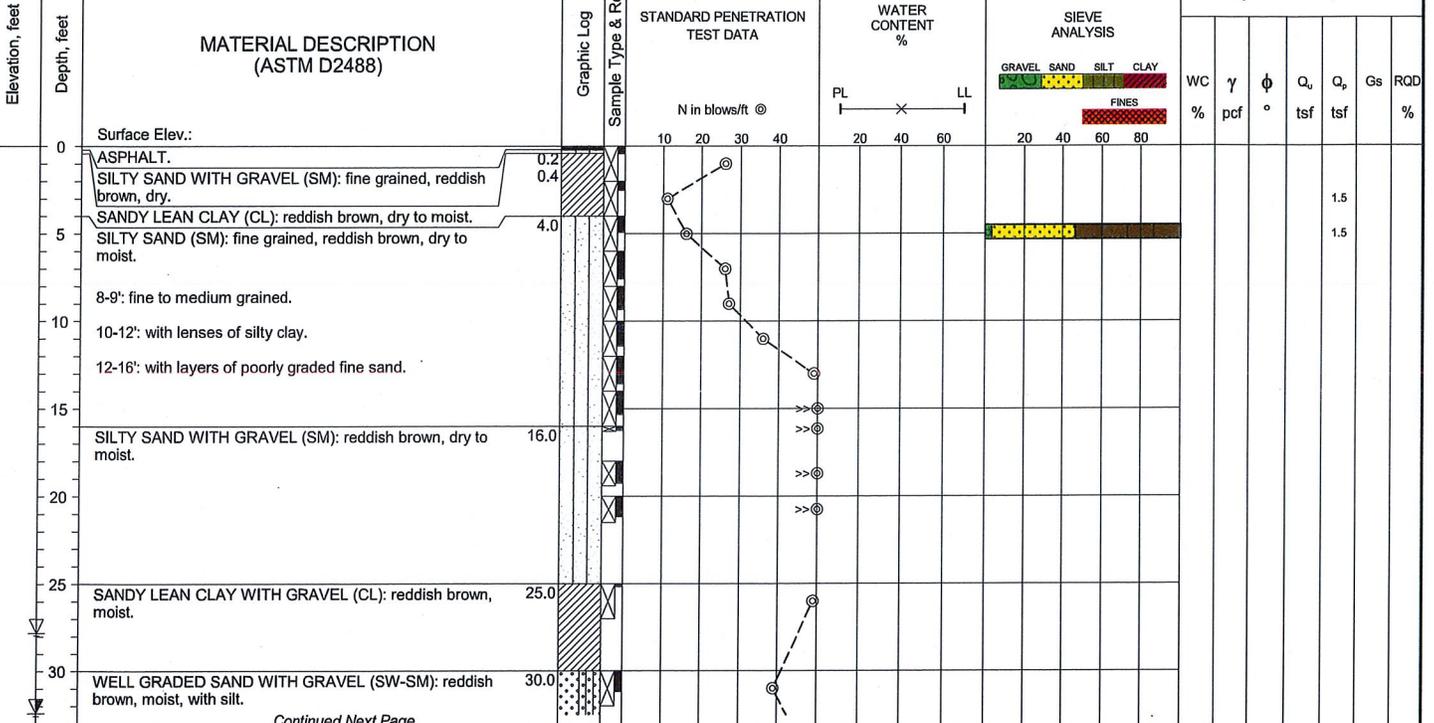
LOG OF BORING PA-1-13

The soils encountered at the site are native glacial till varying from a sandy lean clay, silty sand with varying amounts of gravel, sandy lean clay with gravel, to poorly-graded sand with gravel. The glacial till extends beyond the depth of the boring, which was terminated at a depth of 51.3 feet below existing grade. The consistency of the sandy lean clay above a depth of about 4 feet was stiff to very stiff based on the recorded N-values. Below 4 feet, the relative density of the silty sand increased with depth from medium dense to very dense. The relative density and consistency of the remaining soil layers below a depth of 12 feet to the termination depth were generally very dense or hard. Groundwater was encountered at a depth of 32.4 feet immediately following drilling activities. The borehole was left open overnight in an attempt to measure a stabilized phreatic surface. Groundwater was measured at approximately 27.8 feet (Elevation 1110.2) approximately 24 hours following drilling; however, groundwater levels will fluctuate throughout the year with variations in precipitation, evaporation, and surface runoff. Furthermore, groundwater will likely seasonally perch above the relatively impermeable layers within the glacial till.

Remarks: 1726 Piedmont Avenue. Cobbles encountered during drilling between (hard drilling): 15-17', 23-24', 46-50'.

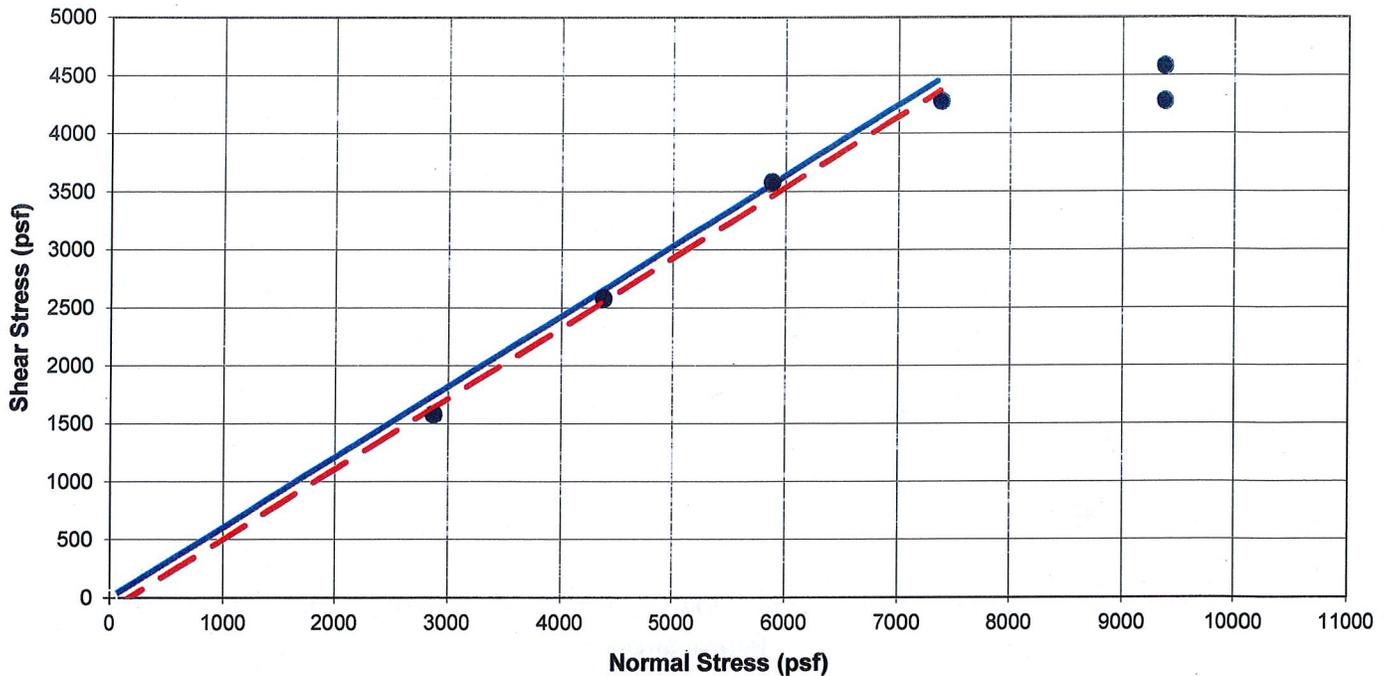
Boring PA-1-13 Test Depth: 7'

Results of the BST indicate the drained friction angle for the glacial till, ranges from approximately 25.2 to 31.2 degrees. Because of the granular nature of the glacial till at the test location depths, and the tests being conducted in a drained condition, cohesion was not measured in the glacial till. These values were utilized in the slope stability calculations and evaluation.

IBHST Friction Angle, ϕ : 31.2 Deg	IBHST Cohesion, c: -100 psf	IBST Corr.: 0.997
Unconfined Comp. Strength, q_u : 0 psf	Modified UC/IBST Cohesion:	0 psf

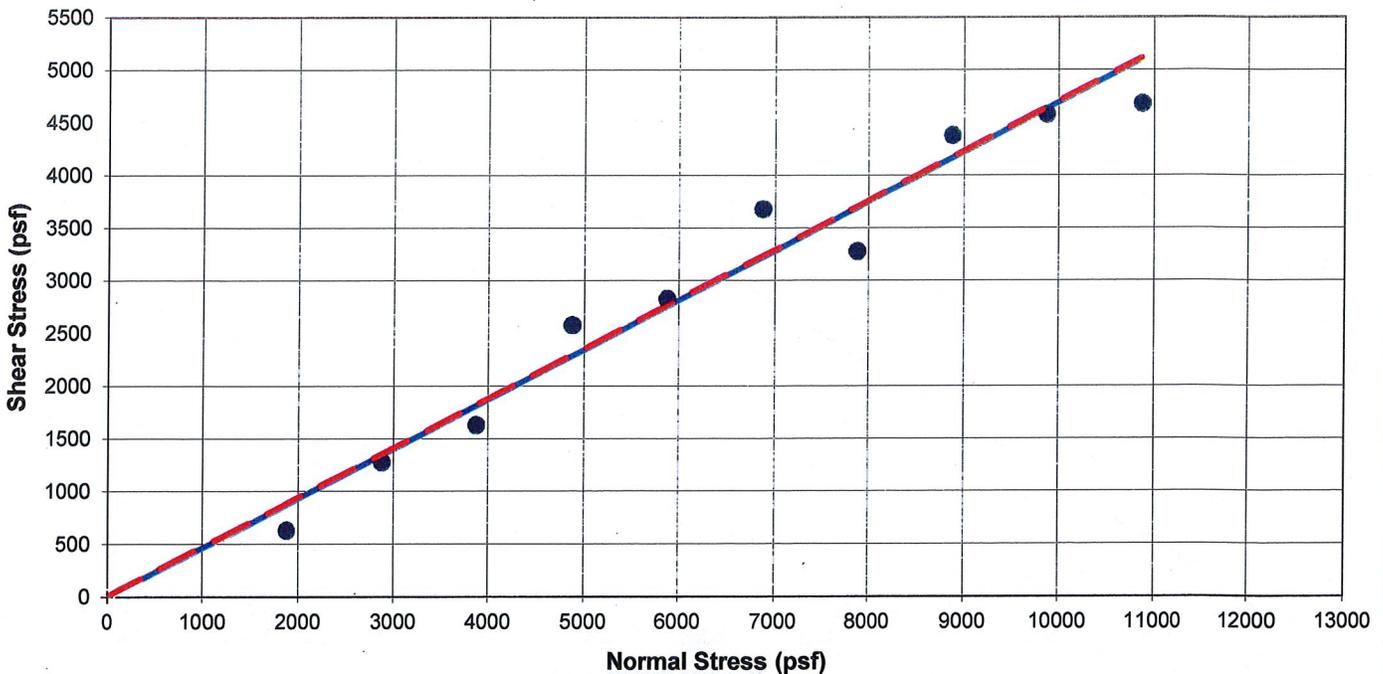
Boring PA-1-13 Test Depth: 13.25'

IBHST Friction Angle, ϕ : 25.2 Deg
IBHST Cohesion, c: 0 psf
IBST Corr.: 0.983
Unconfined Comp. Strength, q_u : 0 psf
Modified UC/IBST Cohesion: 0 psf
