Goodfellowship / Morgan Park Community Club

The Goodfellowship / Morgan Park Community Club is a single level structure that includes a large assembly/meeting room, warming house, game room, office and multi-fixture toilet rooms. An accessible route is provided from the parking lot to the main entry. The kitchen in the assembly/meeting room appears to be a commercial kitchen. The multi-fixture toilet rooms in the lobby currently provide some features of accessibility and have the potential for future modification. The toilet rooms in the warming house area currently provide no features of accessibility.

Transition Plan - (location/priority)

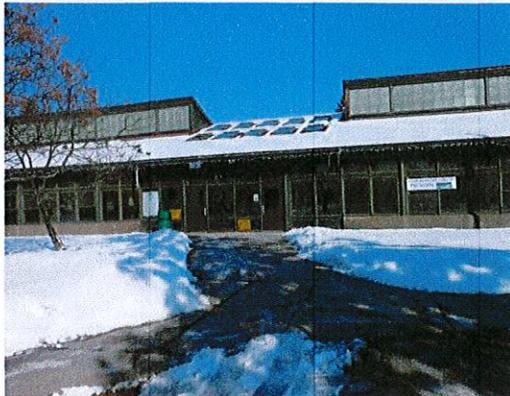
Photo 2: An accessible route is provided to the entry. *This is a good example of accessibility.*

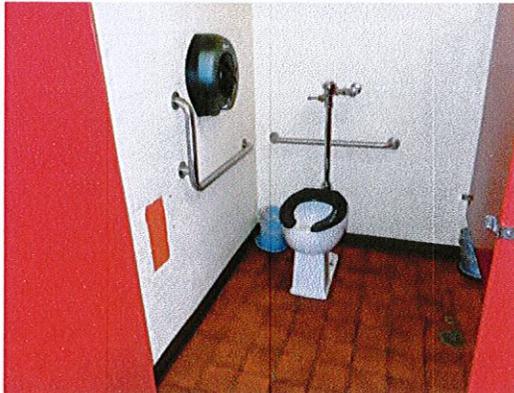
Location JQP # / Item #	Solution / Comments	Qty	Unit Cost	Total Cost	Priority	Estimated Compl. Date	Person Responsible	Actual Compl. Date	Actual Cost
Women's Toilet Room									
22B	16048	Install signage with appropriate raised and Braille lettering. MN 1341 1110.2		1	\$40	\$40	2		
22E	16050	Enlarge to provide a fully compliant 60" minimum wide toilet stall. MN 1341 604.3.1 <i>The toilet compartment is currently 53" wide. Reconfigure the partitions so the accessible stall extends the full depth of the room. Photo 5.</i>		1	\$1,350	\$1,350	2		
22H1	16054	Provide staple style pulls on both sides of the accessible stall door near the latch. ANSI 604.8.3		1	\$50	\$50	2		
22J	16055	Provide stall door hardware that does not require grasping, pinching or twisting to operate. ICC ANSI 309.4		1	\$50	\$50	2		
22K6 (MN)	16052	Remove the existing grab bar configuration and replace with a compliant grab bar configuration. MN 1341 604.5.1 ANSI 604.5.2 <i>Photo 4.</i>		1	\$400	\$400	2

22L (MN)	16053	Reposition the toilet paper dispenser so it is located below the horizontal grab bar. Operable parts should be located within an area 12" - 40" from the rear wall, and 18" minimum above the floor and 1 1/2" minimum below the horizontal grab bar. MN 1341 604.7 <i>Photo 4.</i>		1	\$50	\$50	2		
22Q	16057	Insulate or otherwise protect exposed pipes at lavatory. ICC / ANSI 606.6		1	\$50	\$50	2		
22R	16058	Replace the existing lavatory faucet with hardware that does not require grasping, pinching or twisting to operate. ICC / ANSI 309.4, 606.4		1	\$450	\$450	2		
22V	16059	Install a full-height mirror or provide a mirror where the bottom of the reflective surface is no higher than 40" above the floor. MN 1341 603.3		1	\$300	\$300	2		
22Z	16056	Provide a coat hook positioned so the highest operable part is no higher than 48". ICC / ANSI 604.11		1	\$50	\$50	2		
				<i>Location Subtotal:</i>		\$2,790

Photo 4: View of women's toilet room. Relocate the toilet paper dispenser and replace the grab bars.

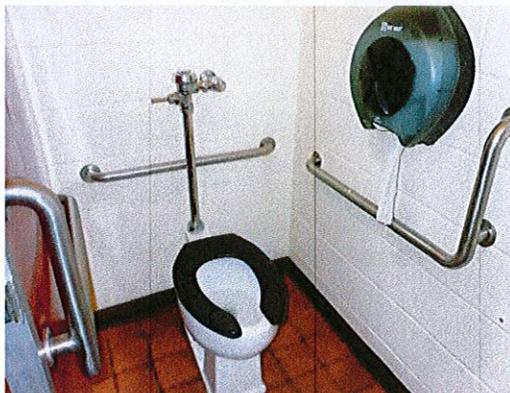
Photo 5: View of men's toilet room. Reposition to the partitions to provide an accessible stall with 60" clearance. Relocate the toilet paper dispenser and replace the grab bars.

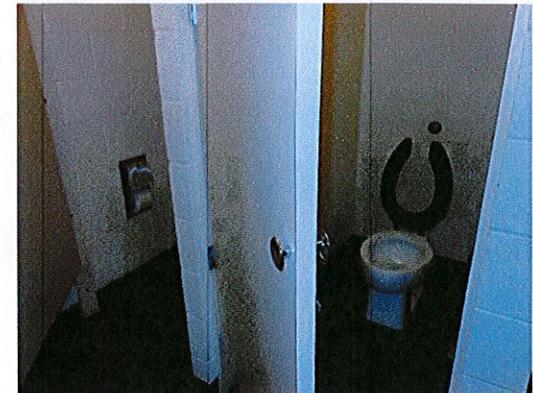
Photo 6: View of toilet room in the warming house. There are currently no features of accessibility provided.
