## **Lincoln Park- Bathroom Building**

Accessibility Review

Transition Plan - (location/priority)

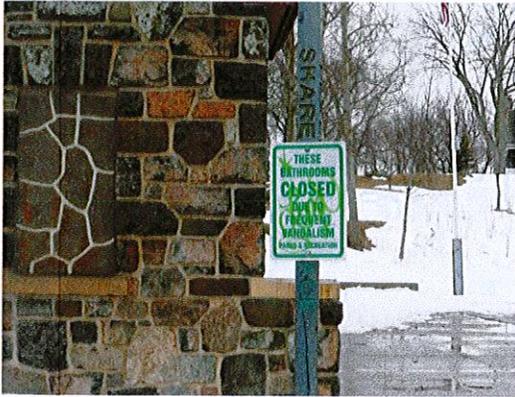
Location	Solution / Comments	Qty	Unit Cost	Total Cost	Priority	Estimated Compl. Date	Person Responsible	Actual Compl. Date	Actual Cost
JQP # / Item #									
<b>Single User Toilet Rooms</b>									
	16675	2	\$0	\$0	3				
	<i>Note: the toilet rooms are currently 'locked because of vandalism'. Photo 1.</i>								
22-20A	16669	2	\$1,500	\$3,000	3				
	Widen door opening to provide a minimum 32" clear opening. ICC / ANSI 404.2.2 <i>Currently provides 29" clear.</i>								
22B	16668	2	\$40	\$80	3				
	Install signage with appropriate raised and Braille lettering. MN 1341 1110.2								
22C3 (MN)	16671	2	\$5,000	\$10,000	3				
	Enlarge the room to provide a minimum 48" of clear floor space in front of the water closet. MN 1341.0442, Subpart 2, Figure MN 1341 28 <i>Photo 2.</i>								
22V	16670	2	\$300	\$600	3				
	Install a full-height mirror or provide a mirror where the bottom of the reflective surface is no higher than 40" above the floor. MN 1341 603.3

**Photo 1:** The bathroom building was closed at the time of site visit due to vandalism.

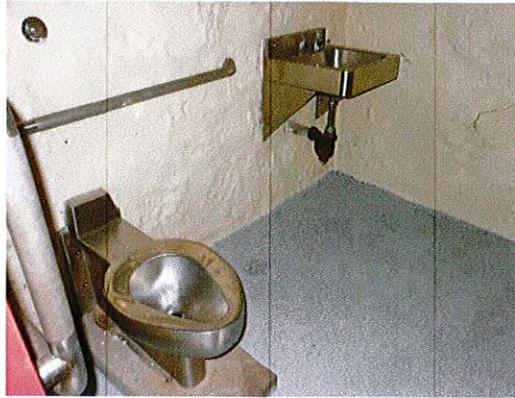
**Photo 2:** The toilet rooms provide many features of accessibility.

Location JQP # / Item #	Solution / Comments	Qty	Unit Cost	Total Cost	Priority	Estimated Compl. Date	Person Responsible	Actual Compl. Date	Actual Cost
<b>Single User Toilet Rooms</b>									
22K (MN) 16672	Install compliant grab bars on the side and rear walls of the water closet. MN 1341 604.5.1 ANSI 604.5.2 <i>Due to the location of the entry door, there is not room to install correct horizontal grab bars on the wall adjacent to the toilet. No action recommended.</i>	2	\$0	\$0	4				
<b>Storage</b>									
20A 16674	Widen door opening to provide a minimum 32" clear opening. ICC / ANSI 404.2.2	2	\$1,500	\$3,000	4				
20D 16673	Provide door hardware that does not require grasping, pinching or twisting to operate, such as lever. ICC / ANSI 404.2.6	1	\$250	\$250	4				
				<i>Location Subtotal:</i>					\$3,250
									<b>Priority # 4 Total \$3,250</b>
