WETLAND DELINEATION TECHNICAL MEMORANDUM

RE: Wetland Delineation – Crystal Village Lot 4 Block 2
SEH No. NEWMB 134676 14.00

This Technical Memorandum details the results of a site investigation for wetlands performed by Short Elliott Hendrickson Inc. (SEH®) in the Crystal Village housing development in Duluth, Minnesota on April 29th, 2016. The parcel assessed was Lot 4, Block 2 of the Crystal Village housing development. The site is approximately 1.2 acres with property boundaries bordering Arrowhead Road to the north and Crystal Drive to the south with forested uplands and residential properties to the east and west (**Figure 1**). The site was investigated for areas meeting the technical criteria of a wetland following the 1987 U.S. Army Corps of Engineers *Wetlands Delineation Manual* and *Regional Supplement to the Corps of Engineers Wetlands Delineation Manual: Northcentral and Northeast Region* (USACE 2012). The field investigation was completed by Kyle Hanson, CWD, SEH Biologist.

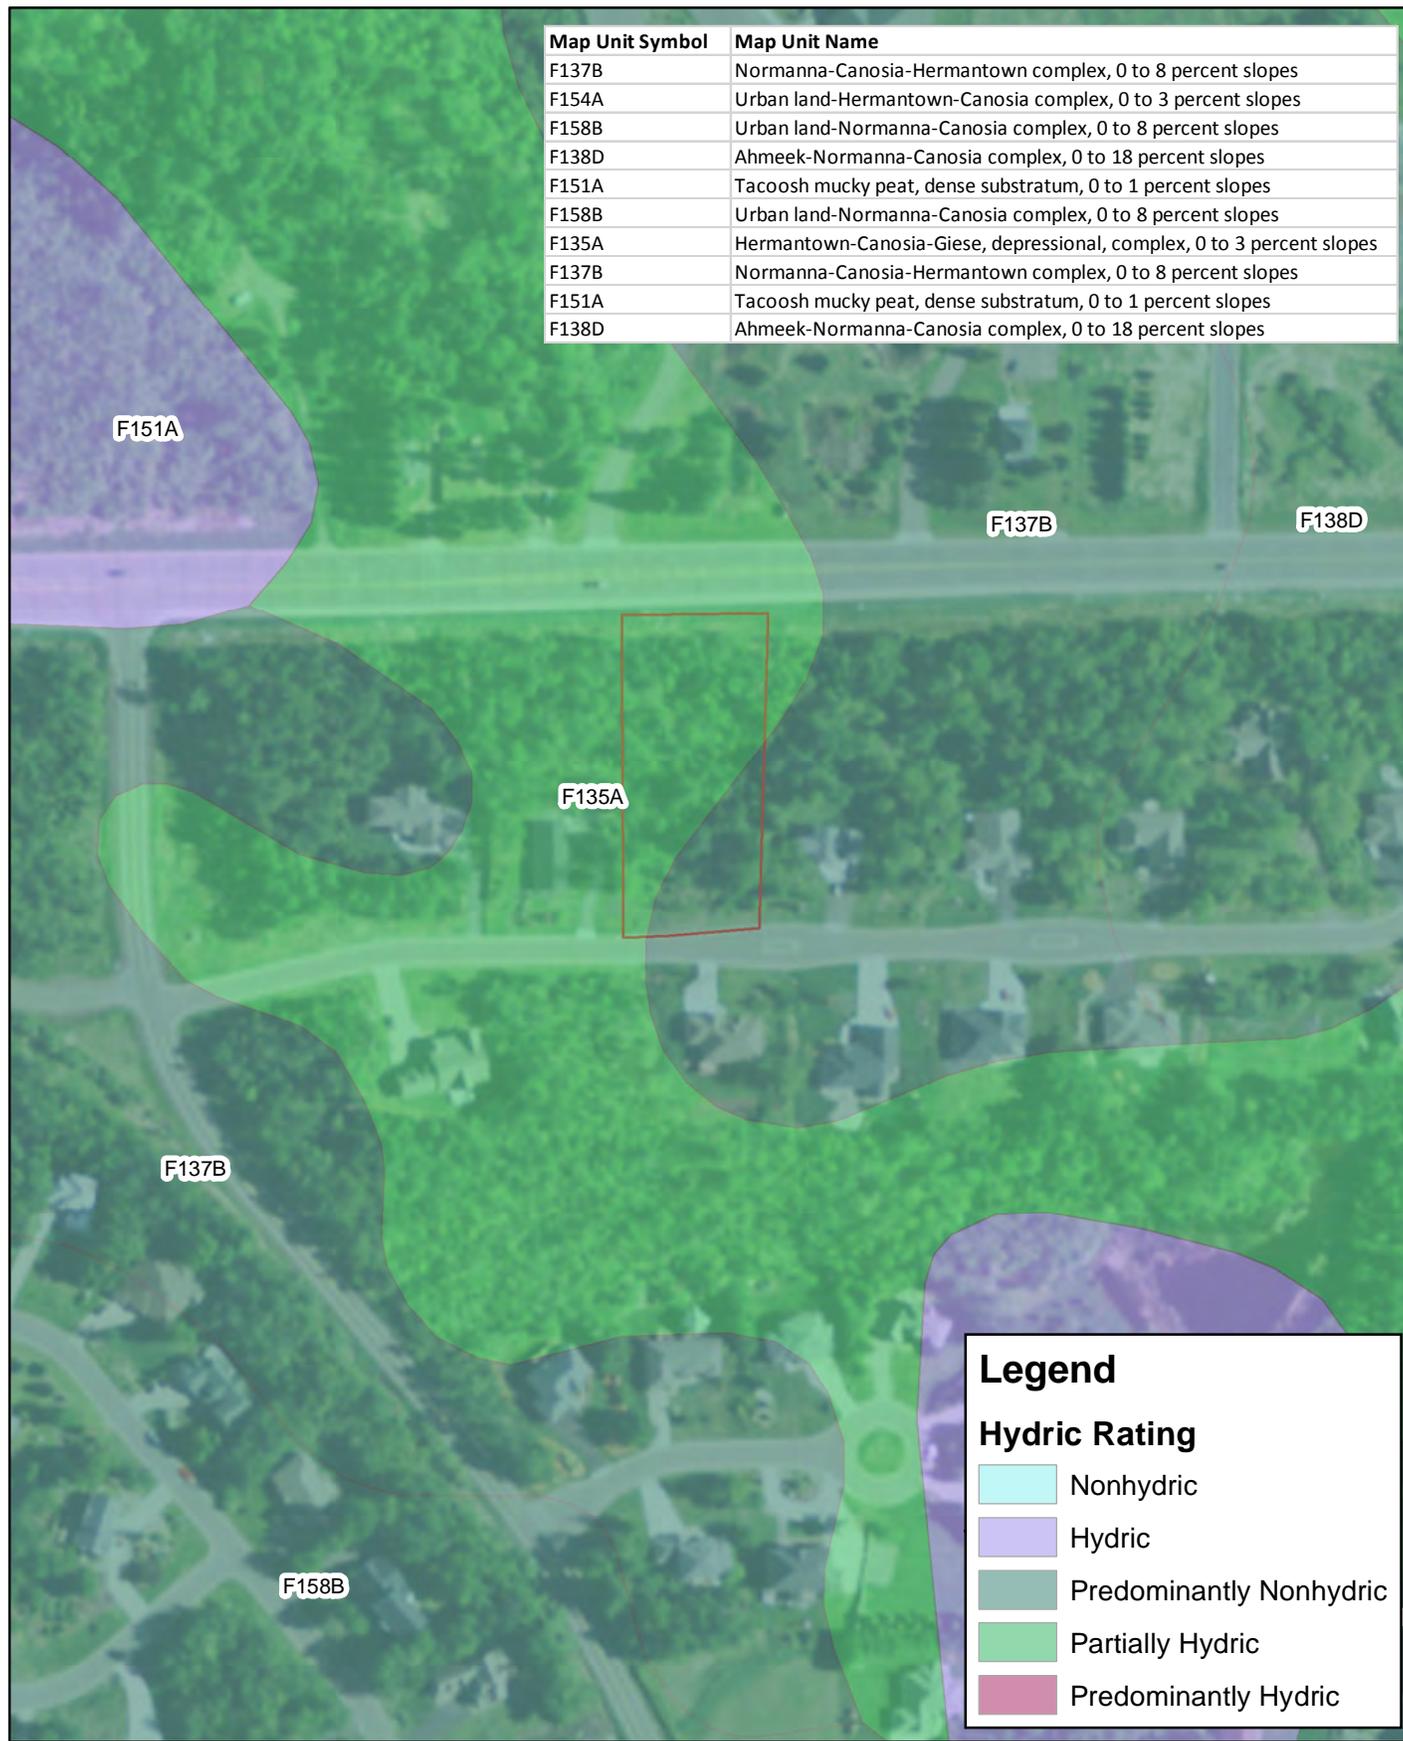
Figure
 2

NRCS SOILS MAP
 Crystal Village Lot 4 Block 2
 Duluth, St. Louis County, Minnesota

Topographic maps, the Natural Resources Conservation Service (NRCS) Web Soil Survey (**Figure 2**), the U.S. Fish and Wildlife Service (USFWS) National Wetlands Inventory (NWI) (**Figure 3**), and the Minnesota Department of Natural Resources (MNDNR) Public Waters Inventory (PWI) (**Figure 4**) were reviewed prior to visiting the site to locate potential wetland habitats. One wetland was identified, mapped, and flagged in the field using pin flags and pink flagging tape within the area of investigation. **Table 1** summarizes the wetland characteristics and detailed field observations are also summarized below.

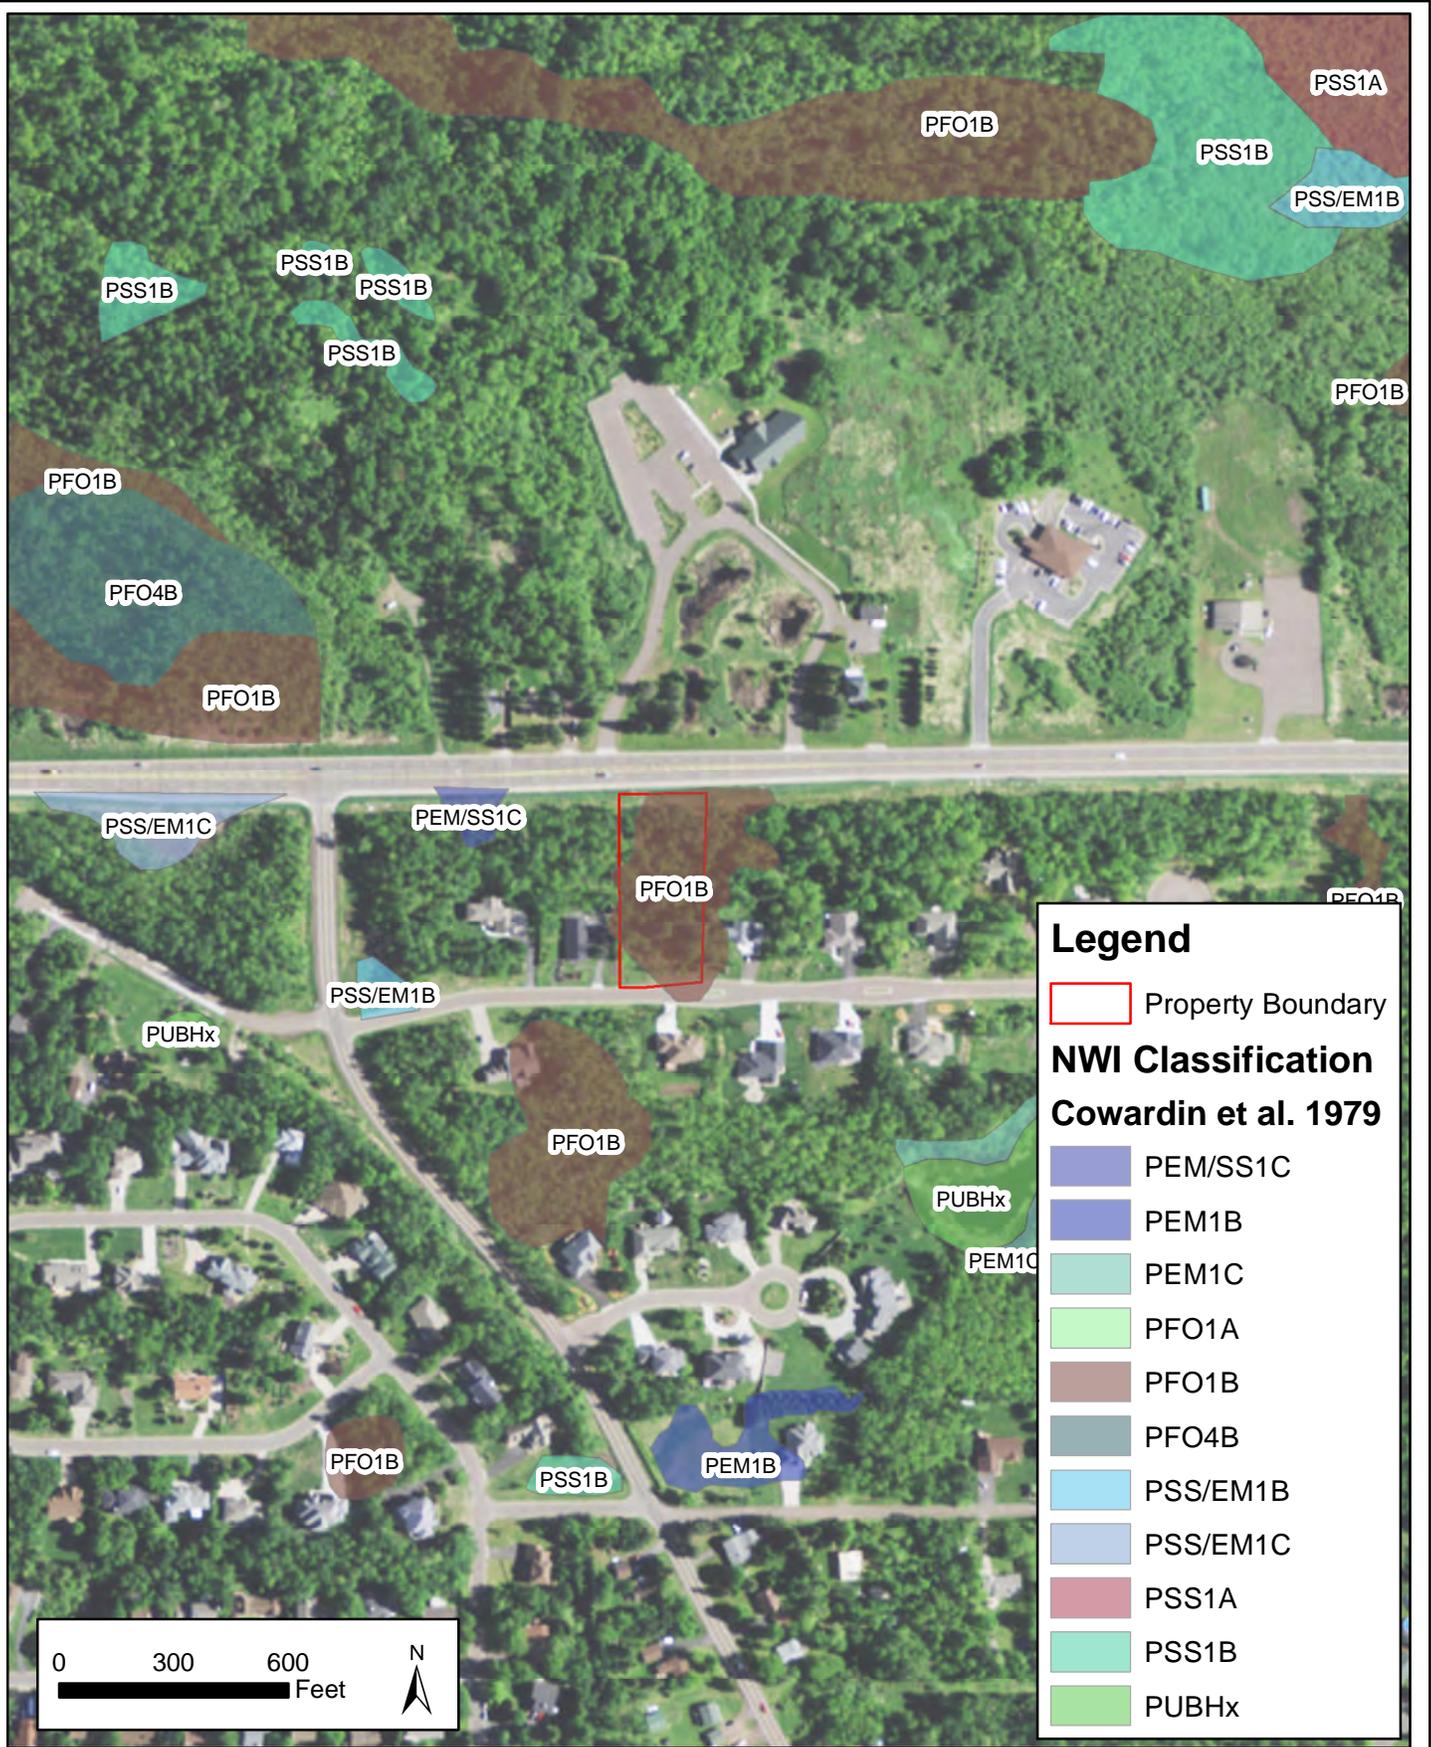
Figure
3

NATIONAL WETLANDS INVENTORY

The NWI map indicates one wetland within the area of interest (**Figure 3**). The nearest PWI identified by the MNDNR is Chester Creek, located approximately 0.5 mile north of the area of interest. No PWI basins or watercourses are located on the site (**Figure 4**).

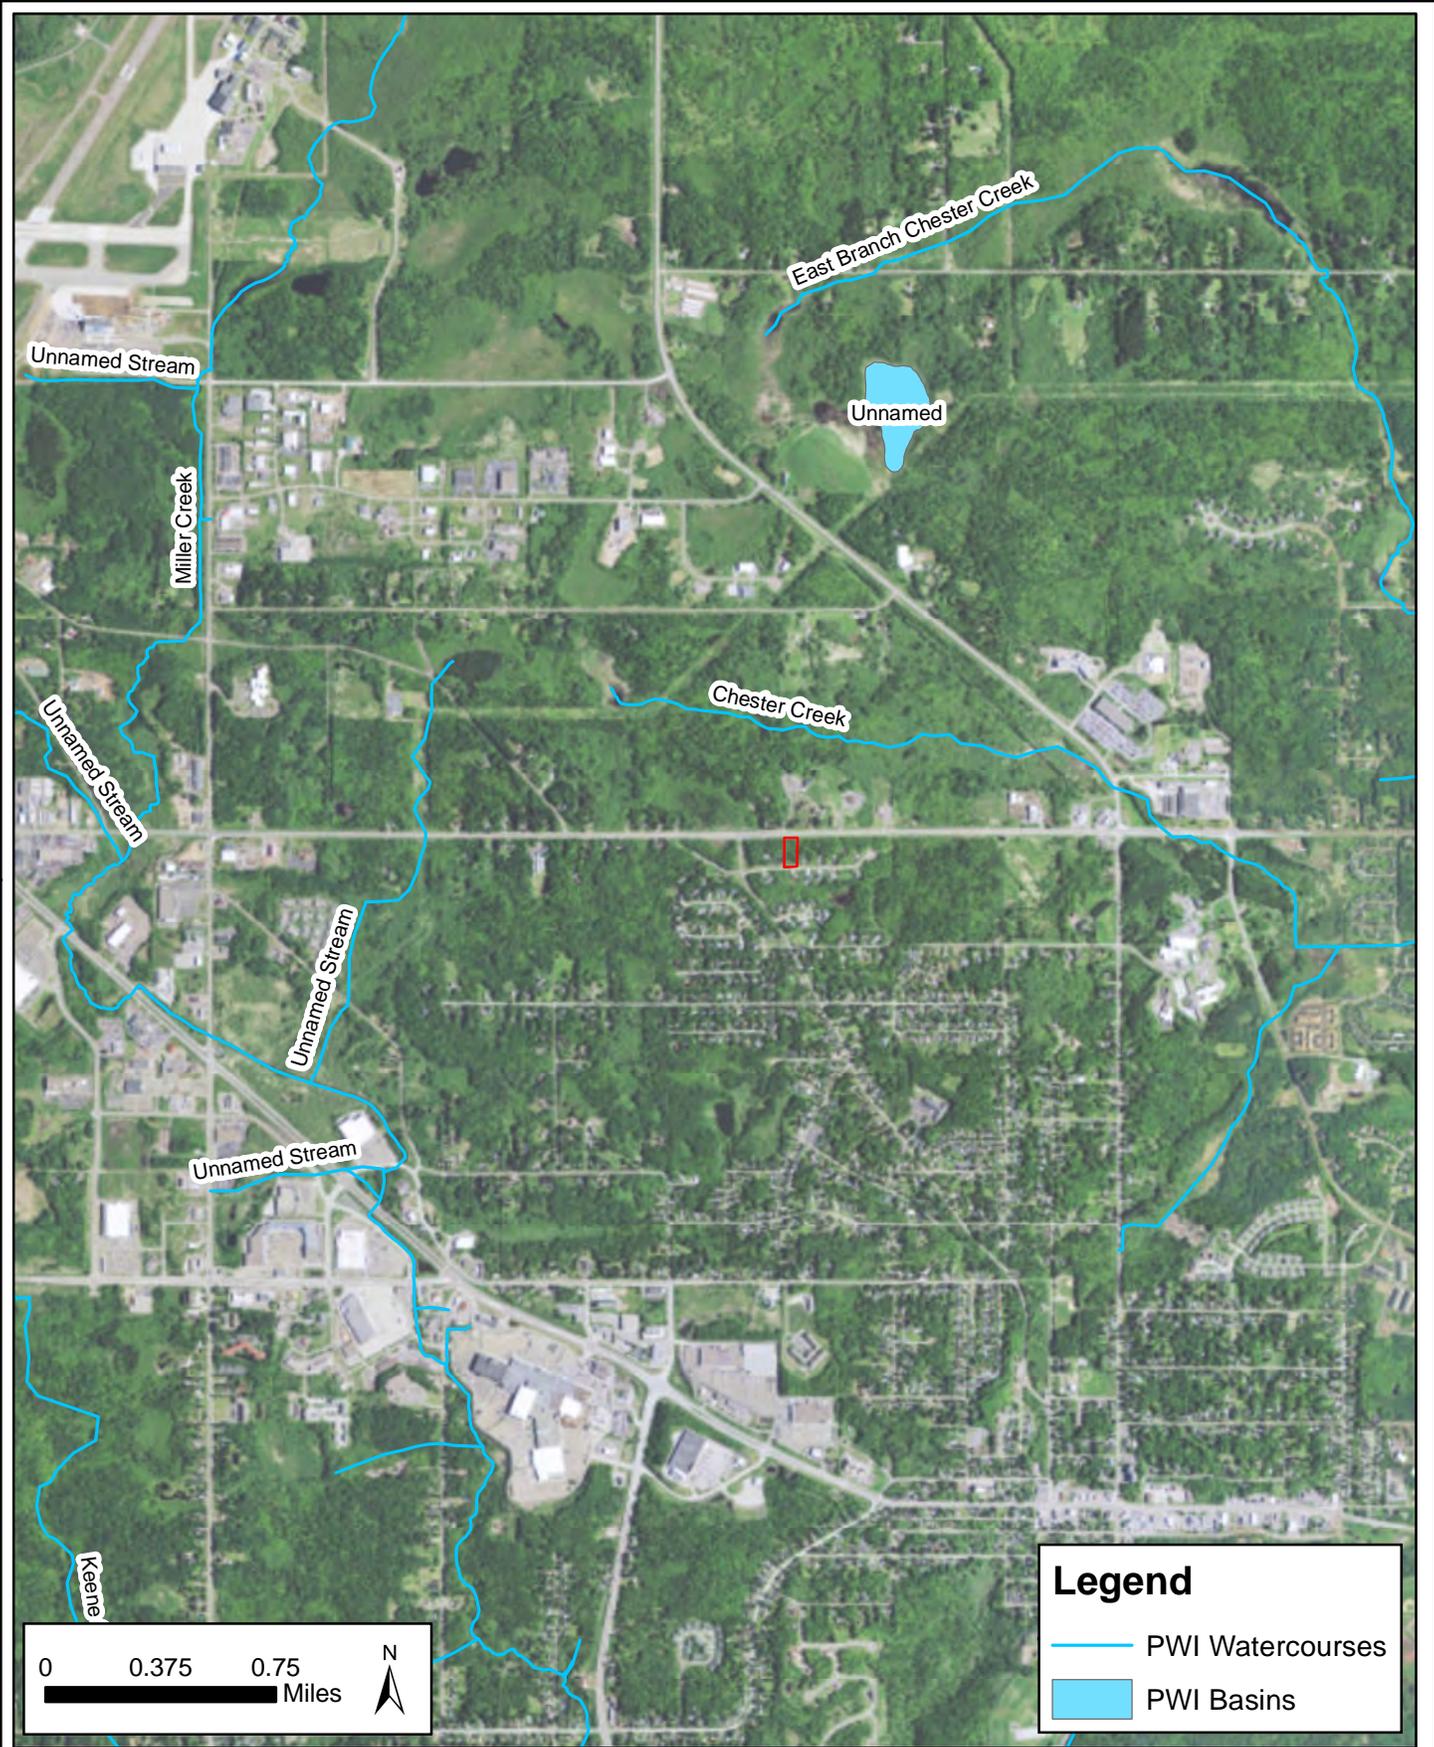
Figure 4

PUBLIC WATERS INVENTORY
 Crystal Village Lot 4 Block 2
 Duluth, St. Louis County, Minnesota

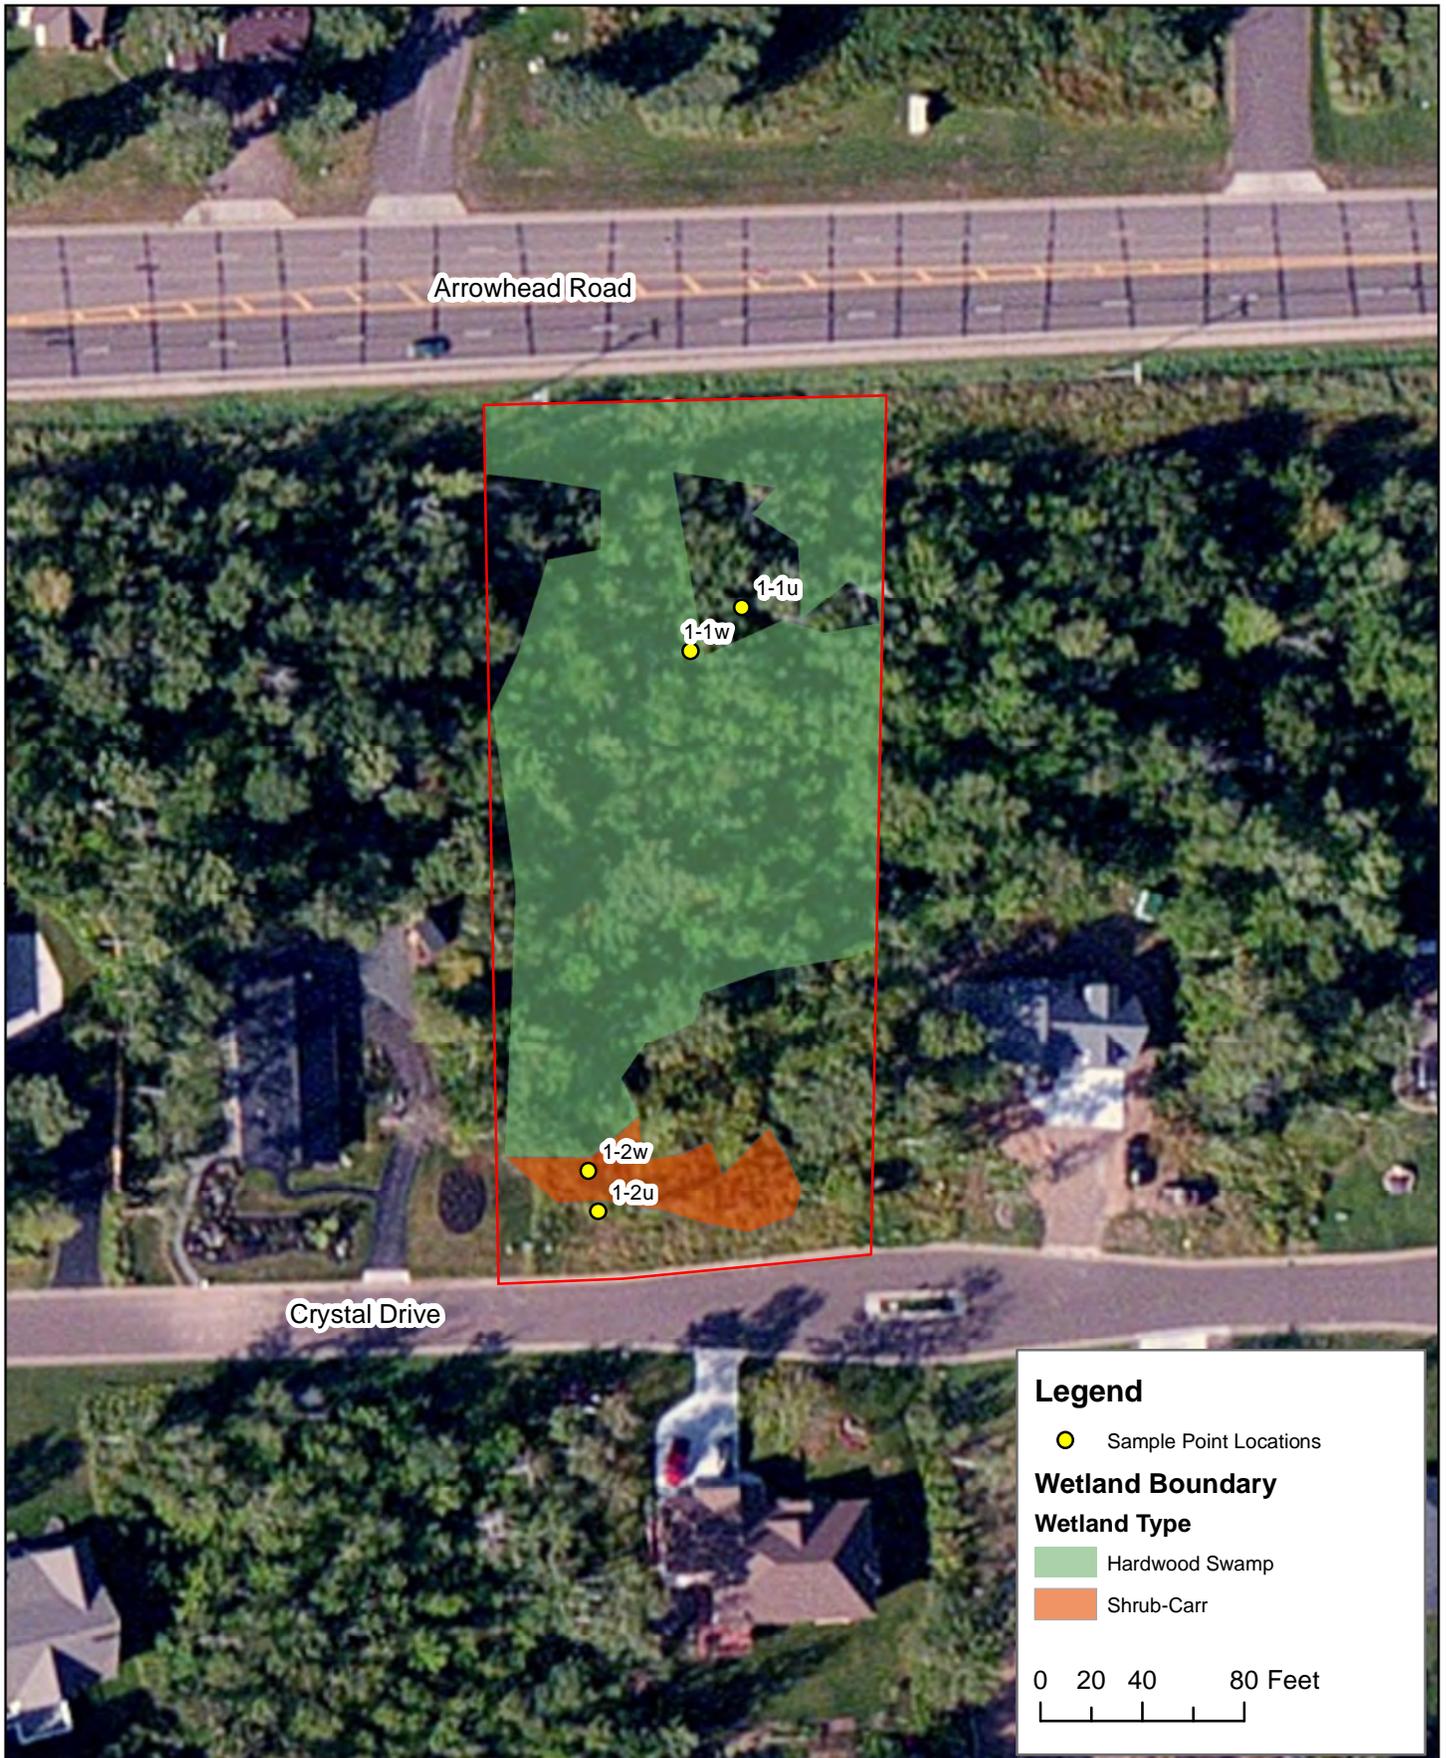
Figure
5

One wetland was identified on the site as a Hardwood Swamp/Shrub-Carr mix and is described below. The wetland borders Arrowhead Road to the north and extends east outside of the property boundary and nears the south and western property boundaries (**Figure 5**). The wetland extends out of the parcel to the east and west; only portions within the area of interest were delineated.

Wetland Location Map
Crystal Village Lot 4 Block 2
Duluth, St. Louis County, Minnesota

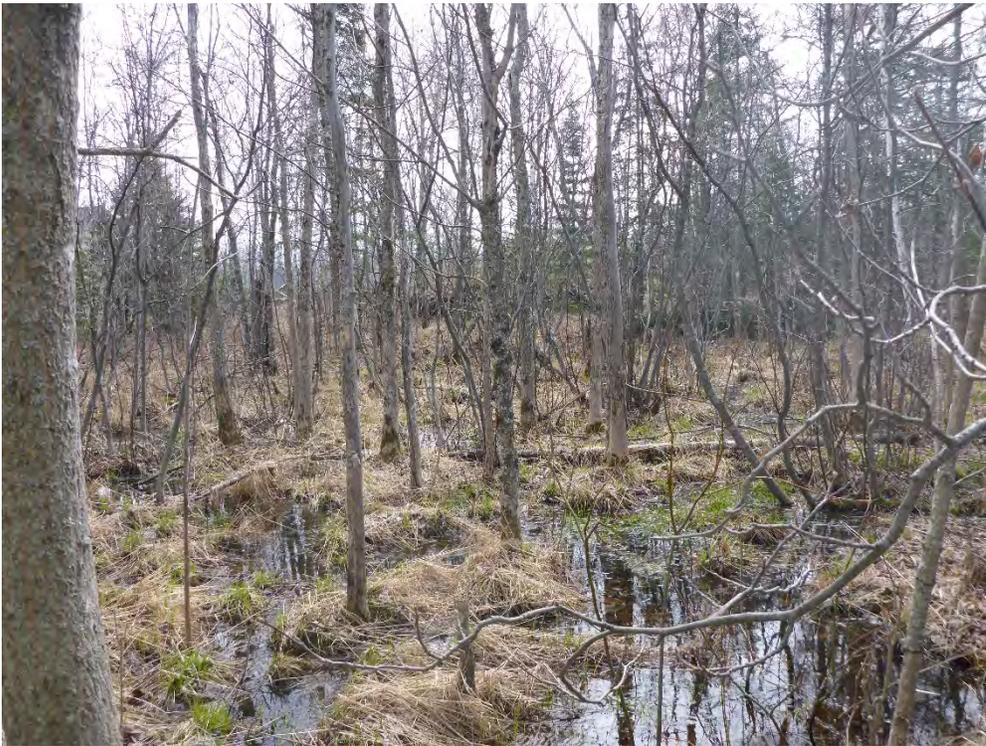
Dominant vegetation observed in the Hardwood Swamp portion of the wetland consisted of black ash (*Fraxinus nigra* – FACW) in the tree stratum, speckled alder (*Alnus incana* – FACW) and pussy willow (*Salix discolor* – FACW) in the shrub/sapling layer, and Canada bluejoint grass (*Calamagrostis canadensis* – OBL) in the herbaceous stratum. At the southwest corner of the property boundary, a small portion of the total wetland area is Shrub-Carr type and is dominated by balsam fir (*Abies balsamea* – FAC) in the tree stratum, speckled alder (*Alnus incana* – FACW) and pussy willow (*Salix discolor* – FACW) in the sapling/shrub stratum, and Canada bluejoint (*Calamagrostis canadensis* – OBL) and common red raspberry (*Rubus idaeus* – FAC) in the herbaceous stratum.

Soils in the Hardwood Swamp portion of the wetland were comprised of 10 YR 2/1 mucky silty clay from 0-6 inches below ground surface. From 6-12 inches below ground surface, soils consisted of 10 YR 4/2 silty clay with 20% redoximorphic concentrations (10 YR 3/6) in the soil matrix. This soil description meets the criteria for hydric soil indicator A10 – 2 cm Muck and F3 – Depleted Matrix. Soils were saturated at the surface and a water table was observed at 2 inches below the surface. Two primary indicators of wetland hydrology were observed: A2 – High Water Table and A3 – Saturation.

Photo 1 Hardwood Swamp portion of Wetland 1

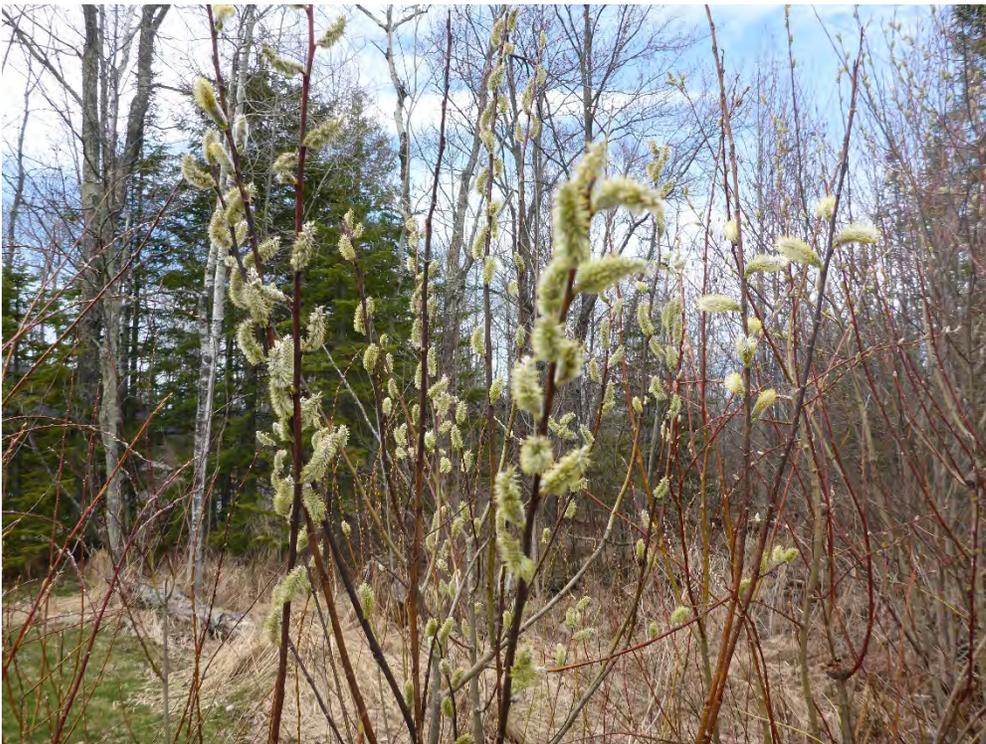
At the southwest corner of the property boundary, a small portion of the wetland area was classified as Shrub-Carr habitat and was dominated by speckled alder (*Alnus incana* – FACW) and pussy willow (*Salix discolor* – FACW) in the sapling/shrub stratum, and Canada bluejoint (*Calamagrostis canadensis* – OBL) and common red raspberry (*Rubus idaeus* – FAC) in the herbaceous stratum. Balsam fir (*Abies balsamea* – FAC) was dominant in the tree stratum. In total, the tree stratum comprised less than 30% total canopy cover. Soils consisted of 10 YR 2/1 fibric peat from 0-12 inches and 10 YR 2/1 muck from 12-48 inches. A water table was observed at three (3) inches below the surface and the primary indicators of wetland hydrology A2 – High Water Table and A3 – Saturation were present.

Photo 2 Willow catkins in Shrub-Carr portion of Wetland 1

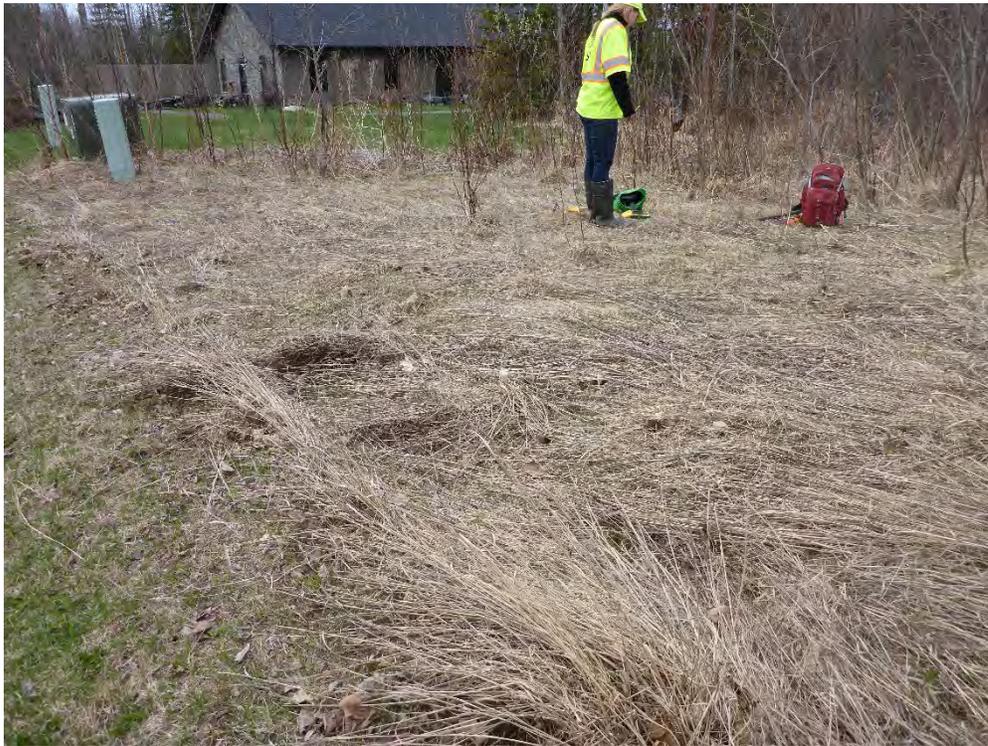
Upland surrounding the Hardwood Swamp portion of the wetland was dominated by quaking aspen (*Populus tremuloides* – FAC) in the tree stratum, American hazelnut (*Corylus americana* – FACU) in the shrub/sapling stratum and northern bracken fern (*Pteridium aquilinum* – FACU) in the herbaceous stratum. Upland soils are composed of 7.5 YR 2.5/2 fine sandy loam from 0-3 inches below ground surface, 7.5 YR 3/3 sandy loam from 3-6 inches, and 7.5 YR 3/4 from 6-12+ inches below ground surface. This soil profile does not meet any of the technical indicators for hydric soils. The hydrology indicator A3 – Saturation at three (3) inches below the ground surface was observed. Despite the presence of soil saturation, this area did not meet hydrophytic vegetation or hydric soil indicators and is therefore classified as upland habitat.

Photo 3 Upland adjacent to Wetland 1

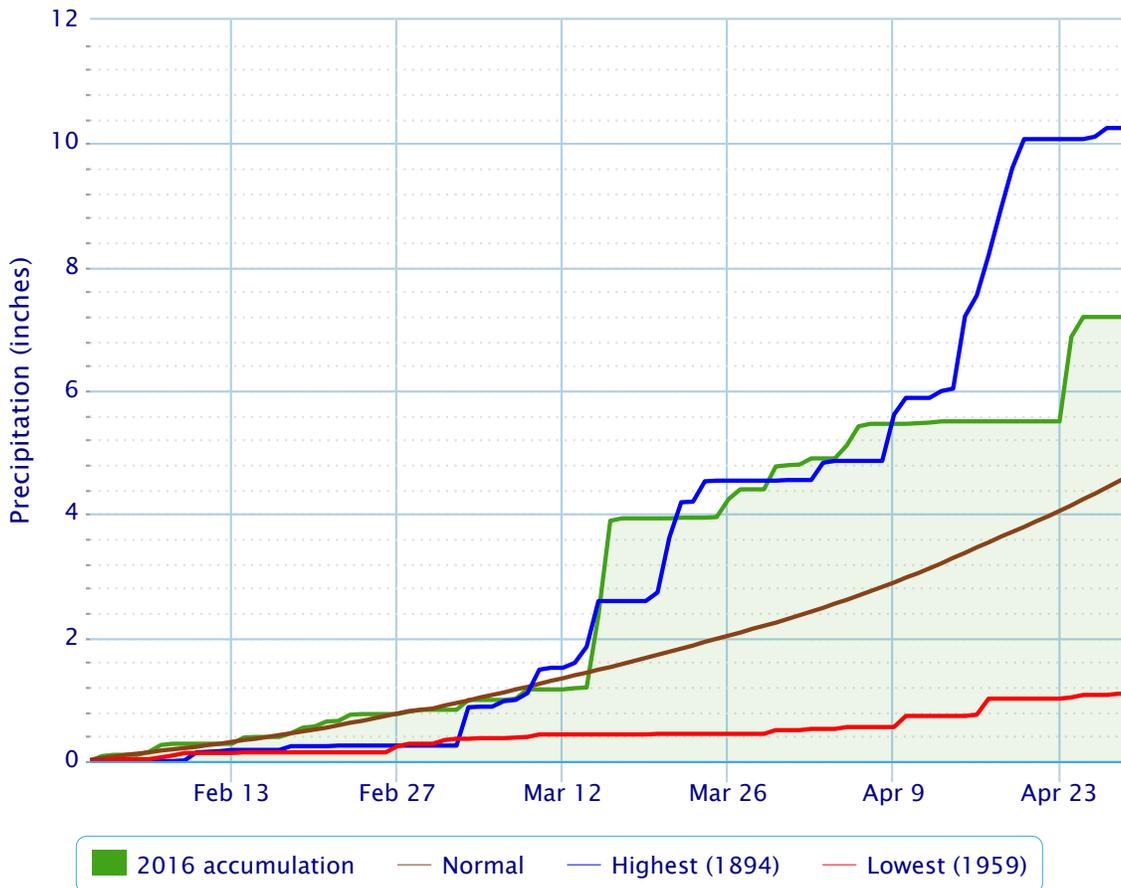
Accumulated Precipitation – Duluth Area, MN (ThreadEx)

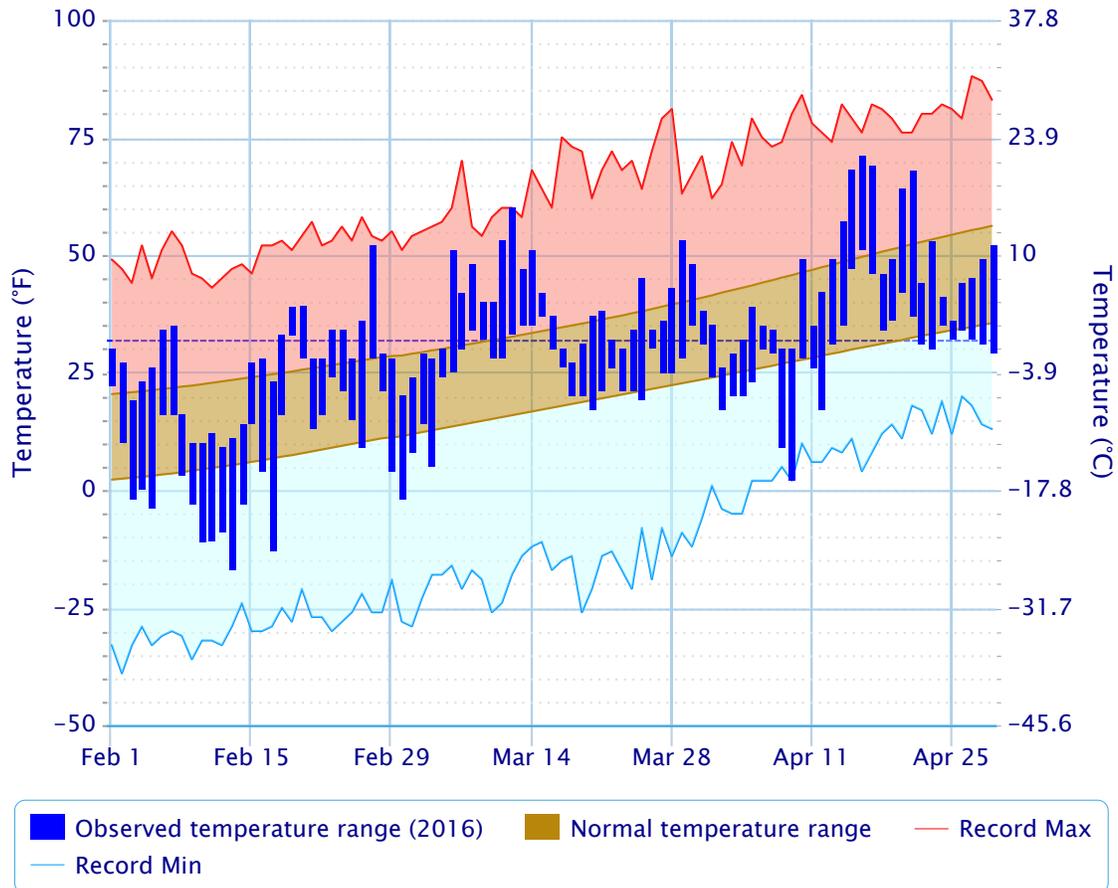
Daily Temperature Data – Duluth Area, MN (ThreadEx)

Period of Record – 1874-05-13 to 2016-05-19. Normals period: 1981-2010. Click and drag to zoom chart.
