STAFF REPORT

File Number	PL 14-034	Contact	Jenn Reed Moses, jmoses@duluthmn.gov	
Application Type	Shoreland Variance	Planning Commission Date	May 13, 2014	
Deadline for Action	Application Date	April 8, 2014	60 Days	June 7, 2014
	Date Extension Letter Mailed	April 22, 2014	120 Days	August 6, 2014
Location of Subject	1726 Piedmont Ave			
Applicant	Dennis Michaud	Contact	boman12120@yahoo.com	
Agent	Kate Kubiak, South St. Louis SWCD	Contact	218-723-4946; kate.kubiak@southstlouisswcd.org	
Legal Description	010-2880-00270			
Site Visit Date	N/A	Sign Notice Date	April 22, 2014	
Neighbor Letter Date	April 24, 2014	Number of Letters Sent	32

PL 14-034
1726 Piedmont Avenue

**Re: Slope Stability Evaluation
1726 Piedmont Avenue
Duluth, MN 55811**

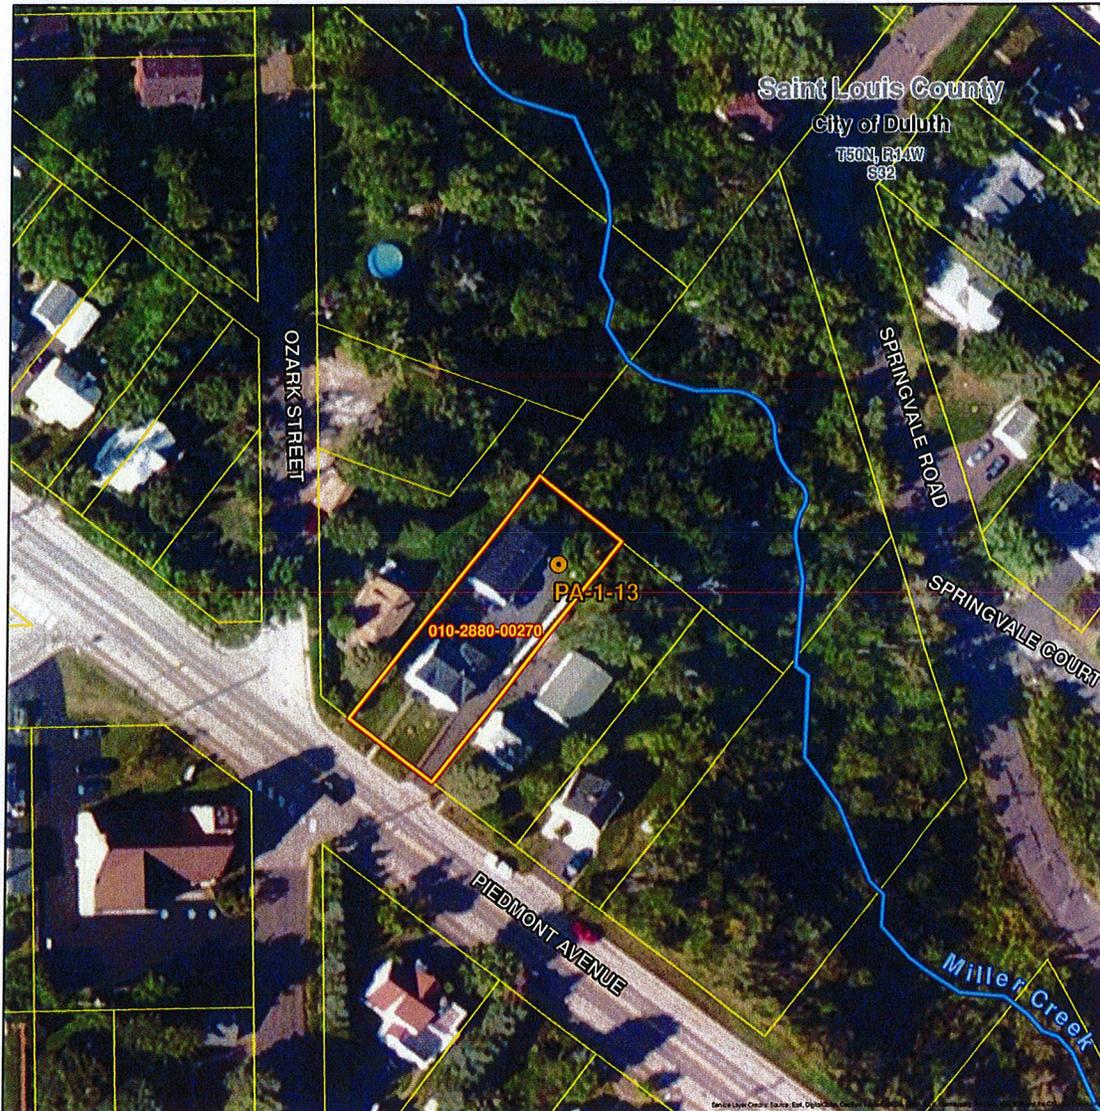
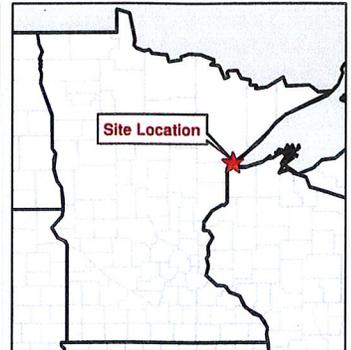
Figure 2 – Boring Location

The geotechnical investigation consisted of a standard penetration test (SPT) boring advanced with a CME 55 truck-mounted drill rig using hollow-stem auger drilling methods. Soil sampling and classification was generally performed continuously to a depth of 22 feet and at 5-foot intervals thereafter to a final depth of 51.3 feet in accordance with ASTM D-1586. The test boring, identified as PA-1-13, was advanced within the existing driveway approximately 15 feet from the crest of the slope. Figure 2 depicts the boring location.
