# Lincoln Park | Mini Master Plan

City of Duluth | DRAFT February 12, 2016

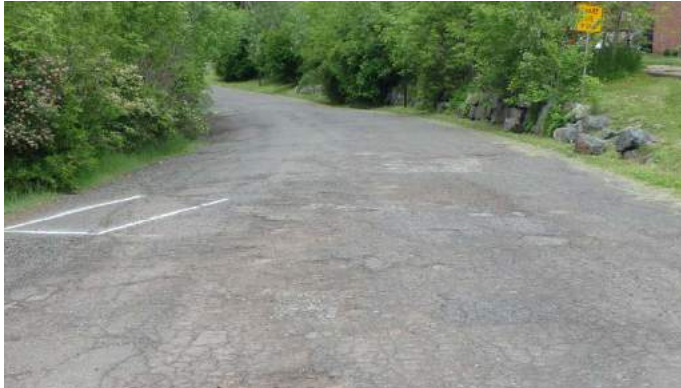
*Roadway paving and shoulders in poor condition throughout park*

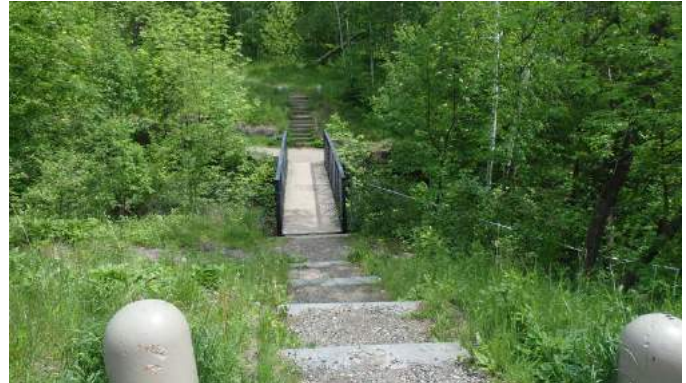
*Lack of wayfinding and well defined trail access points within park*

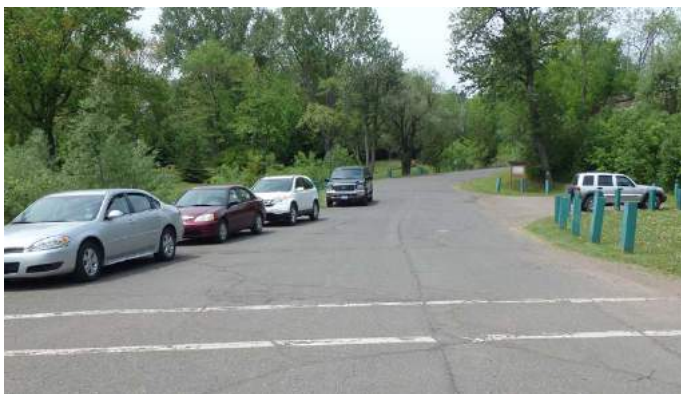
*Lack of defined parking areas and pedestrian circulation along Lincoln Park Drive*

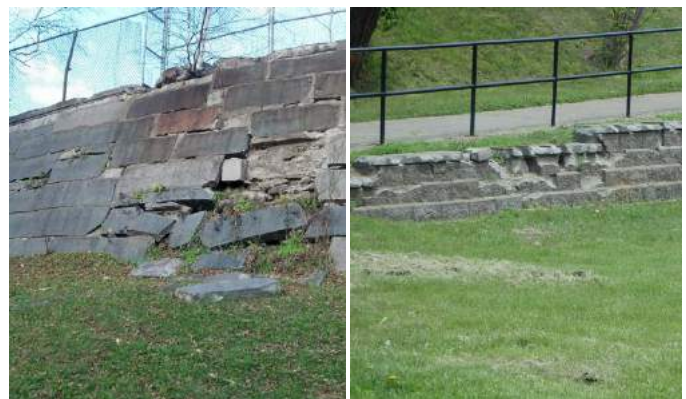
*Retaining wall Infrastructure in need of tuck pointing repair or replacement*

The upper terrace athletic field area on the east side of the park is somewhat disconnected from the rest of the park because of its higher elevation and primary access along 25th Avenue. The existing stone clad retaining wall is also failing and in need of short term repair or long term replacement. Other recommendations call for an expanded parking lot which can support overflow parking for the rest of the park, restoration of the athletic field turf area, the addition of half court basketball, and establishing a new, more direct stair connection to the lower parking lot and adjacent park amenities.

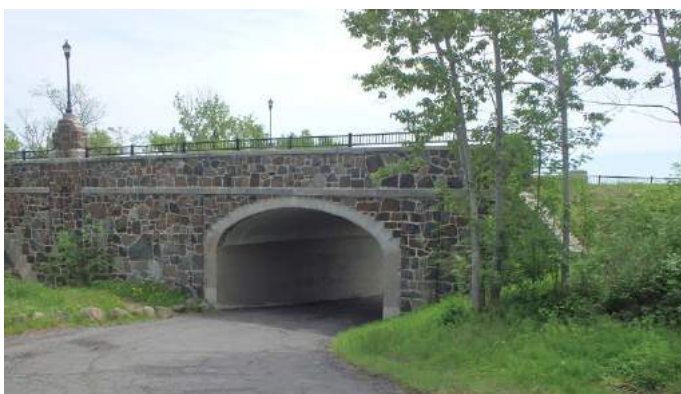
*Poor approach sight lines for vehicular and pedestrian traffic at 10th Street bridge underpass*

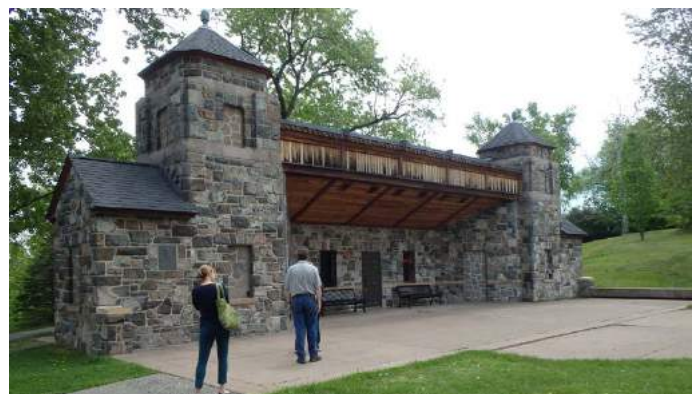
*No operational restroom facilities in pavilion building*

With a desire to attract more visitors, providing running water and flush toilet facilities should be addressed at the park. The existing restroom facilities located in the WPA pavilion have not been used since the 2014 arson fire and efforts should be made to complete repairs or incorporate new restrooms in a new picnic shelter adjacent to the playground. After the pavilion is repaired, efforts should continue to place the building on the National Register of Historic Places. To minimize risks for future vandalism at the restroom building, the addition of security lighting and highly visible cameras will help prevent unwanted after hours activities in the park. Organizing volunteer neighborhood watch group patrols can also help deter crime and illegal dumping activities occurring in the park.

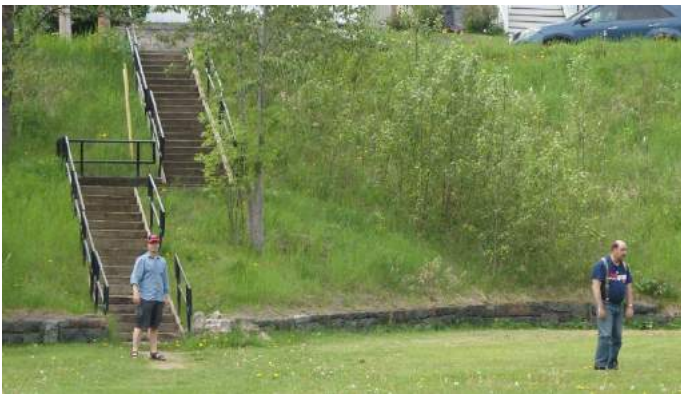
*Steep grades around perimeter of park limit ADA access opportunities from surrounding neighborhoods*

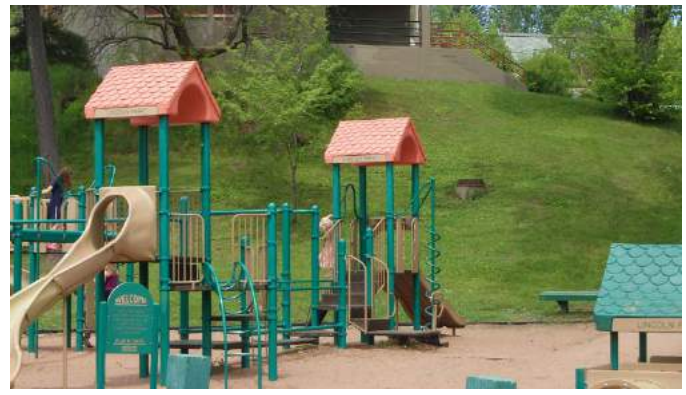
*Existing playground does not meet ADA accessibility requirements*

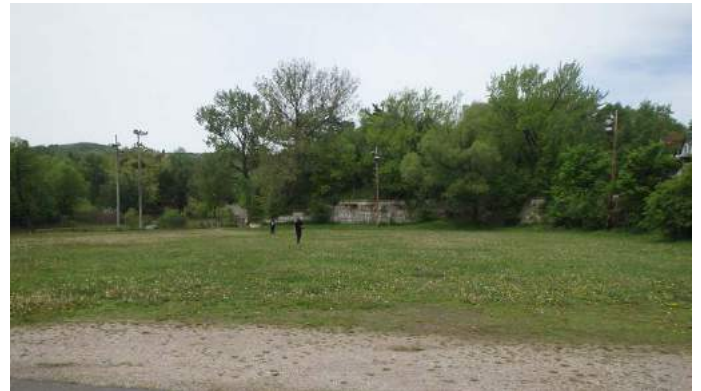
*Upper terrace athletic field in poor condition and is disconnected from other park amenities and activities*

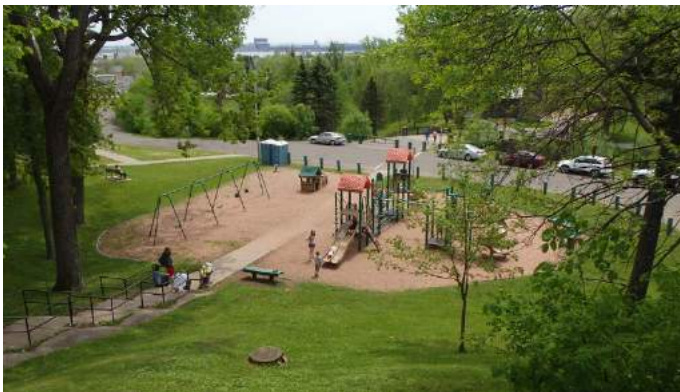
*Existing playground is separated from existing gathering and picnic areas*

A new and more expansive playground area is proposed on the south side of Miller Creek to better integrate it with the existing picnic open space and shelter, restroom facilities, and trail circulation connected to a new natural play area with climbing boulders, tree fort building area, and informal picnic area with a small shelter near elephant rock.

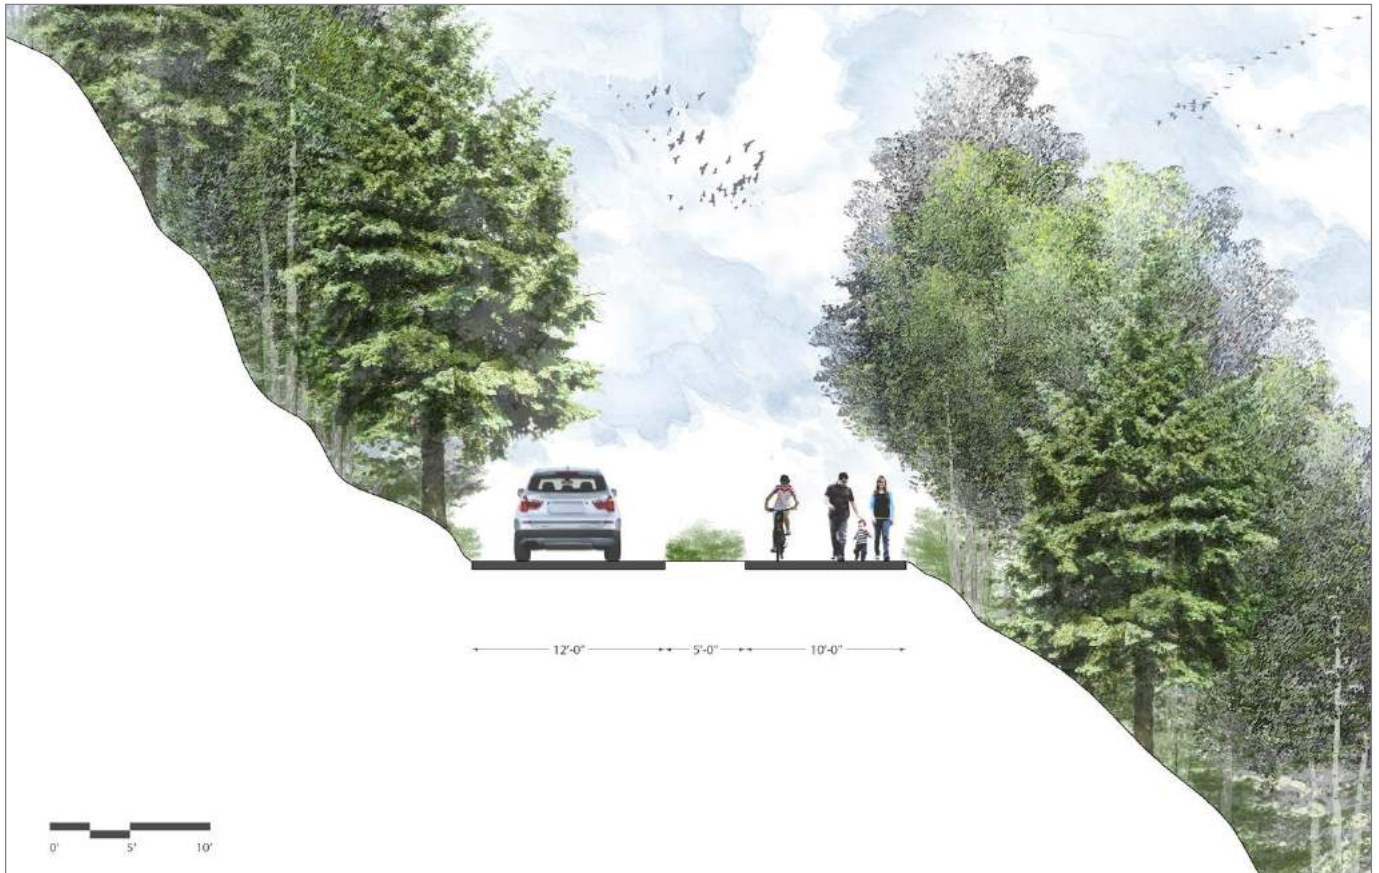
This option considers converting Lincoln Park Drive to a one way road (direction to be determined by additional traffic study) and dedicating a separated trail to accommodate bike and pedestrian traffic.

**OPTION A:** One-way vehicle traffic, vegetated buffer, and combined bicycle/pedestrian trail

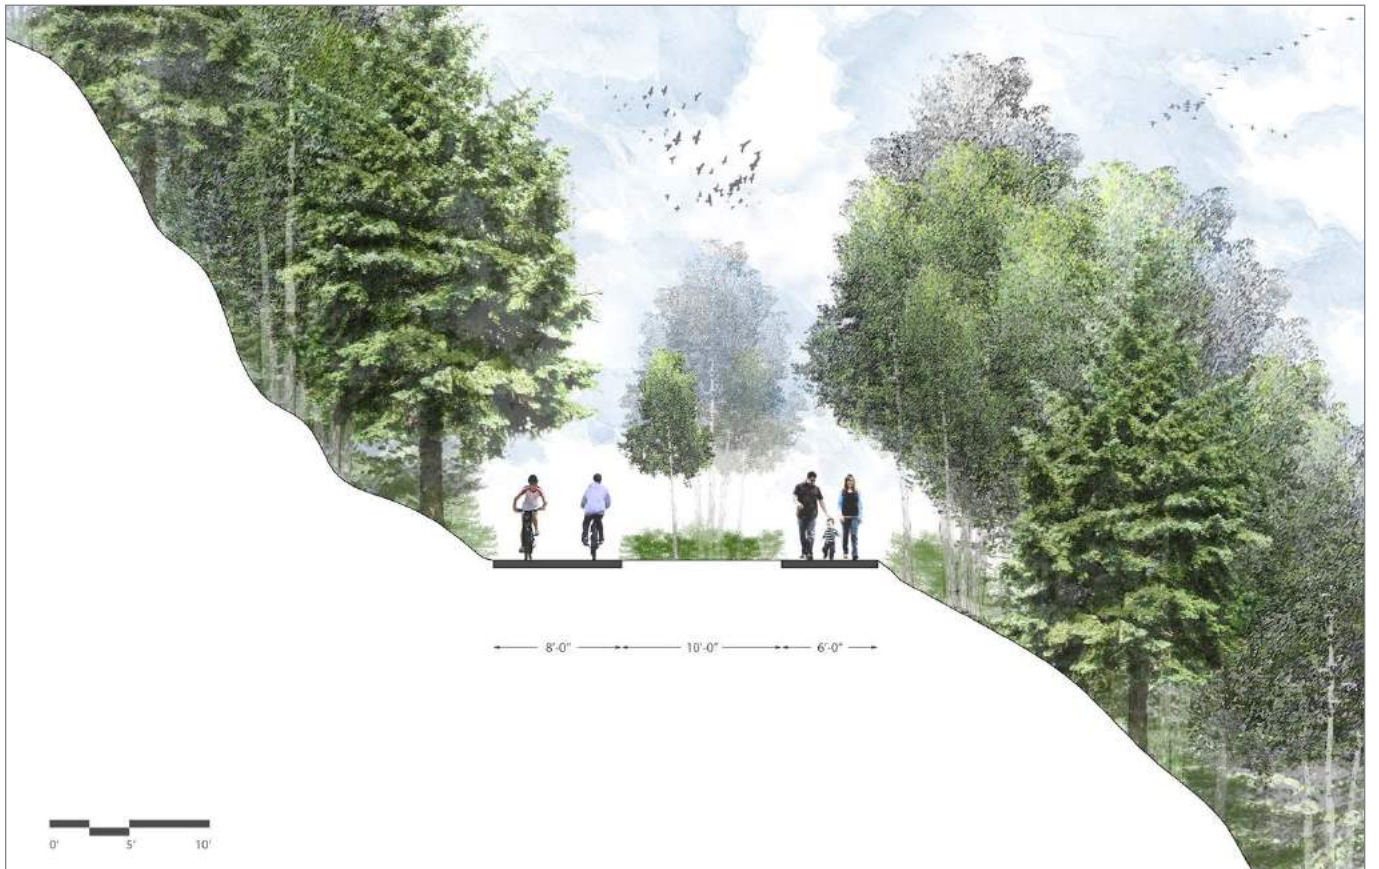
This option considers converting Lincoln Park Drive to a designated bike and pedestrian trail system with the bike trail designed to accommodate police and fire emergency vehicle use.

**OPTION B:** Bicycle trail, vegetated buffer, and pedestrian trail
