Minnesota Point Boat Landing- Bathroom Building

Transition Plan - (location/priority)

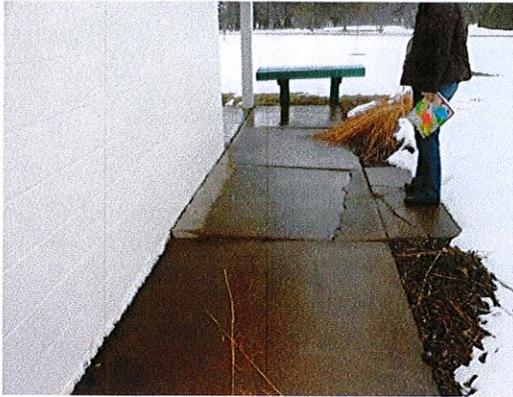
The Minnesota Point Boat Landing Bathroom Building is located across from Park Point. The short route from the parking lot is currently damaged with an abrupt rise in the concrete. An ambulatory accessible stall is provided in the men's and women's toilet rooms, but there is not currently a fully accessible 5' wide stall.

Photo 1: Patch/replace the damaged section of sidewalk.

22V 16656	Install a full-height mirror or provide a mirror where the bottom of the reflective surface is no higher than 40" above the floor. MN 1341 603.3 <i>Currently at 48".</i>	1	\$300	\$300	3				
				<i>Location Subtotal:</i>					\$990
Route									
08D 16645	Bevel abrupt rises in the sidewalk. ANSI 303.3 <i>Photo 1.</i>	1	\$50	\$50	3

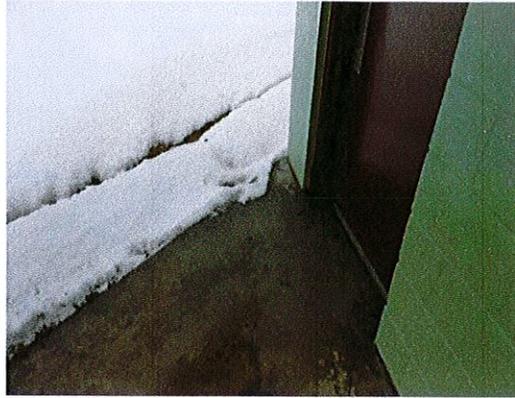
Photo 2: Expand the concrete at the approach to the entry door to the men's toilet room.

Location JQP # / Item #	Solution / Comments	Qty	Unit Cost	Total Cost	Priority	Estimated Compl. Date	Person Responsible	Actual Compl. Date	Actual Cost
Men's Toilet Room									
12B1 16658	Extend sidewalk to provide appropriate maneuvering clearance on the latch side of the door. ICC / ANSI 404.2.3.1 <i>Photo 2.</i>	1	\$500	\$500	3				
22B1 16653	Relocate compliant sign to the wall adjacent to latch side of door, 48" minimum to the baseline of the lowest Braille characters and 60" maximum to the baseline of the highest tactile character. ICC/ANSI 703.3.10, 703.4.5	1	\$40	\$40	3				
22Q 16654	Insulate or otherwise protect exposed pipes at lavatory. ICC / ANSI 606.6	1	\$50	\$50	3				
22T 16657	Lower the towel dispenser/dryer so the highest operable part is no higher than 48" (44" maximum if located above lavatory or counter). ANSI 308 <i>Currently at 62".</i>	1	\$50	\$50	3				
22U 16655	Relocate the existing soap dispenser so the highest operable part is no higher than 48" (44" maximum if located above lavatory or counter). ANSI 308 <i>Currently at 60".</i>	1	\$50	\$50	3

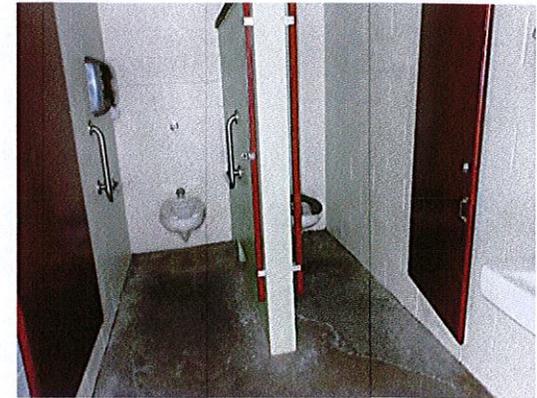
Photo 3: View of women's toilet room. An ambulatory accessible stall has been provided, but not a 5' wide stall.

22E3	16652	Create a fully compliant 60" minimum wide toilet stall by combining two existing stalls and removing one toilet. Ensure that the new stall provides 48" minimum in front of the toilet, side and rear grab bars, toilet paper dispenser located below the horizontal grab bar, a low coat hook, easily operable stall locking hardware and staple style pulls on both sides of the stall door. MN 1341 604.3.1 <i>Creating an accessible 5' wide stall would require removing 1 of the 2 fixtures. Photo 3.</i>	1	\$1,350	\$1,350	4			
------	-------	---	---	---------	---------	---	--	--	--
